# **Lava Falls Rapid in Grand Canyon: Effects of Late Holocene Debris Flows on the Colorado River**

**Professional Paper 1531**

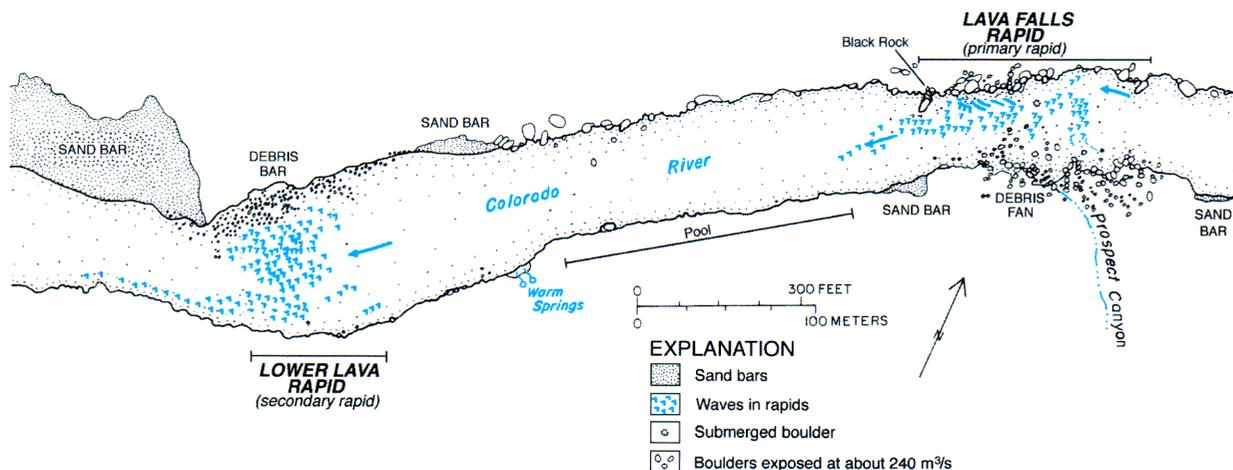
**Figure 2.** Lava Falls and Lower Lava rapids showing geomorphic features of the Colorado River. The Prospect Canyon debris fan, shaped and reworked by the Colorado River, forms a rapid-pool-rapid configuration that is typical of Grand Canyon rapids (Webb and others, 1989). The main rapid arises from the constriction and deposition of boulders on the bed of the river. The pool downstream, which has twin eddies, is a recirculation zone (Schmidt and Graf, 1990) that deposits sand bars at certain water levels. Lower Lava Rapid is controlled by cobbles and boulders that have been eroded from the Prospect Canyon debris fan, transported through the pool, and deposited as the first of a series of alternating debris bars downstream from the rapid.

Several effects of debris flows on the Colorado River are well illustrated at Lava Falls Rapid (fig. 2). Deposition of a debris fan in the river creates a rapid by constricting the width of the river and raising its bed elevation (Howard and Dolan, 1981). Similar types of deposition have caused partial or complete damming of valleys in other river systems (Stringfield and Smith, 1956; Gallino and Pearson, 1985; Benda, 1990; Miller, 1994). Local features, such as unusually large boulders or the arrangement of boulders on the bed, cause spectacular hydraulic features that impede navigation. Flow around the debris fan and through the rapid may be supercritical (Kieffer, 1987; Miller, 1994), leading to

Lower Lava Rapid is the next obstacle downstream from Lava Falls (fig. 2). This secondary rapid, formed from cobble and boulder outwash from Prospect Canyon debris fan, consists of a tight river bend against a vertical limestone cliff. Although Lower Lava Rapid is not noteworthy by itself, it forms a distinct hazard to passengers and crew when boats overturn in the main rapid upstream.

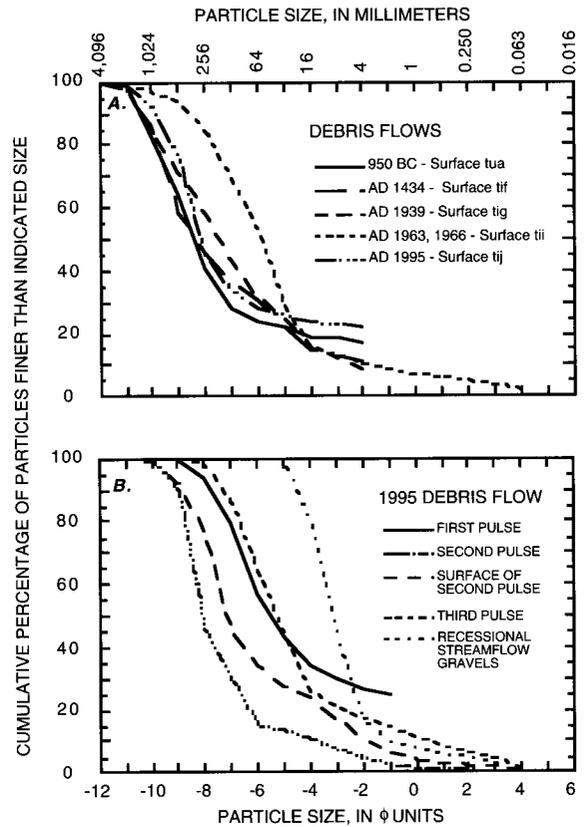
**Figure 4.** Particle-size distributions for debris flows in Prospect Canyon. *A*, Prehistoric and historical debris flows (see pl. 1 for unit descriptions). *B*, Pulses of debris flow and recessional flow during the 1995 event.

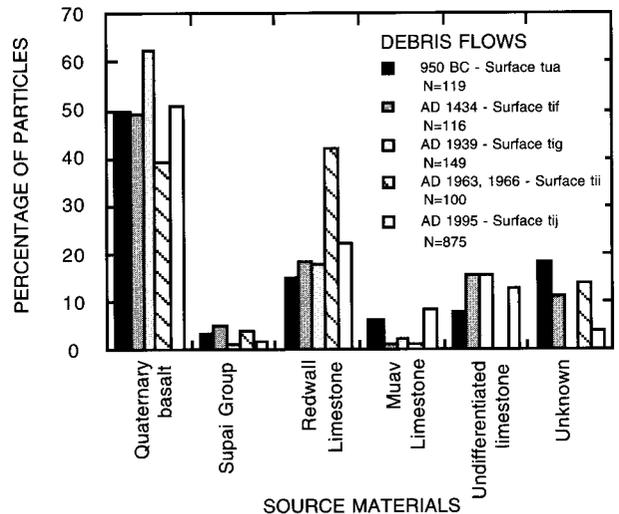
**Figure 5.** Source materials transported by five debris flows in Prospect Canyon.

Between 39 and 63 percent of the clasts present in debris flows from Prospect Canyon are Pleistocene basalts (fig. 5). The lithologies of particles on debris fans vary by reach according to bedrock exposures in tributary canyons; we have not found extra local particles on Holocene debris fans in Grand Canyon. Typical Grand Canyon debris-flow deposits are dominated by clasts from the Redwall and Muav

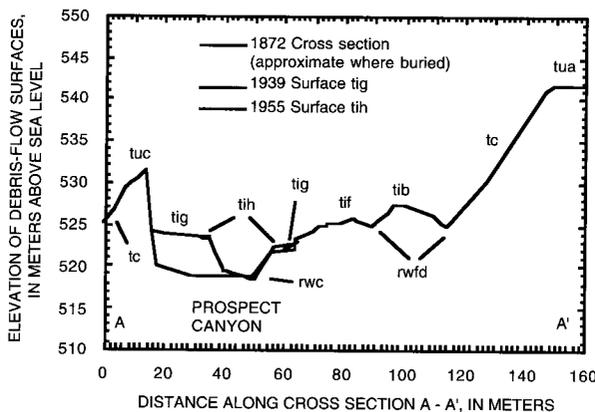
**Figure 6.** Cross section showing the relative elevations and positions of the upper and inset debris-flow surfaces along section A - A' (see pl. 1).

We estimated the discharge of three historical Prospect Canyon debris flows from depositional and photographic evidence along or upstream from section A - A' (fig. 6, pl. 1). The surface of a moving fluid typically rises on the outside of a bend and drops on the inside. The difference in flow elevation is attributable to centrifugal forces exerted on the fluid mass and is termed "superelevation" (Apmann, 1973). The mean velocity ( $V_s$ ) is related to the difference between the flow elevations on the outside and inside of the bend by

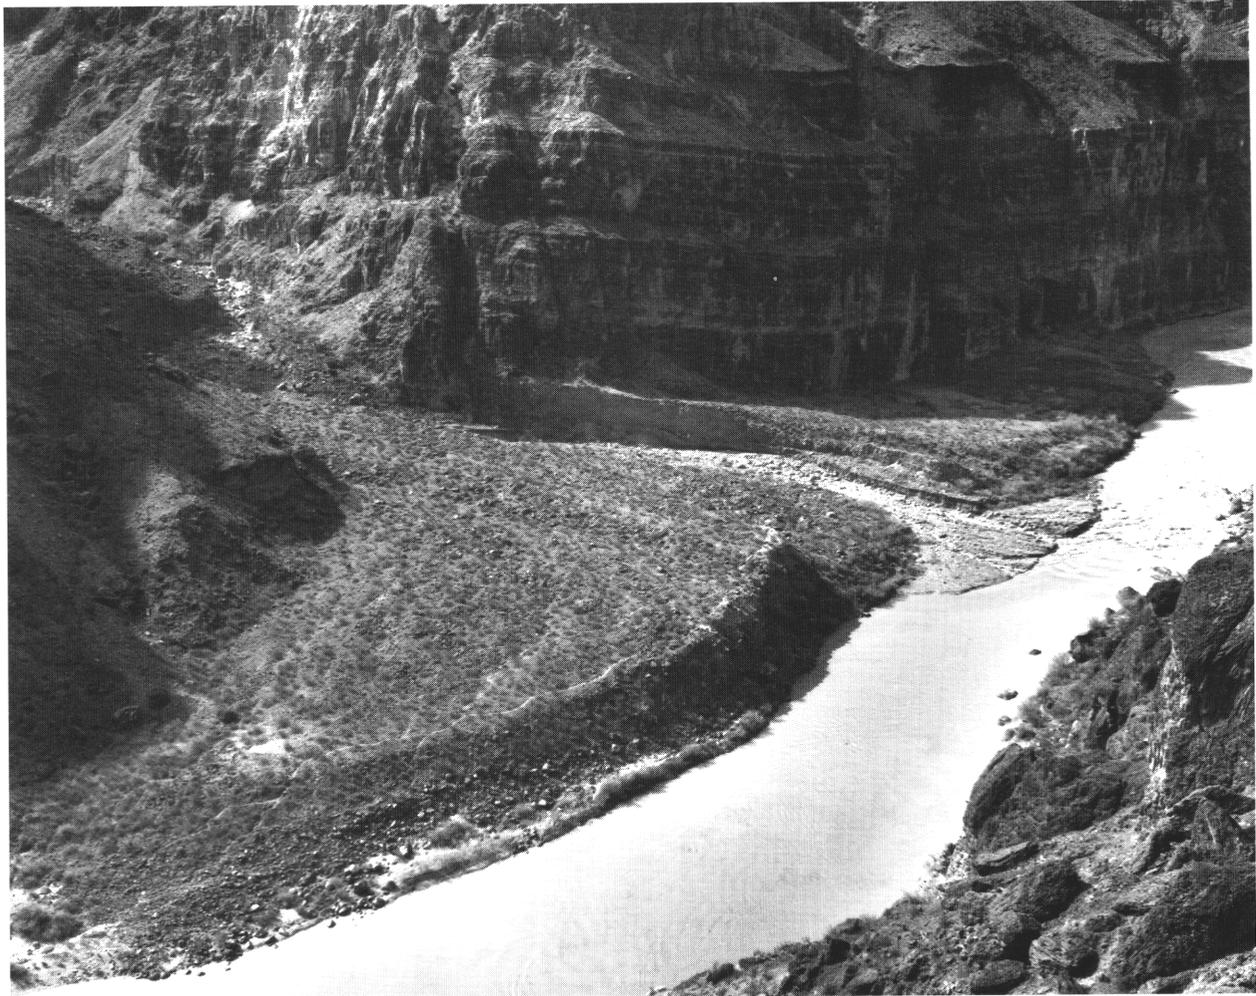
**Figure 7.** View of the Prospect Canyon debris fan on March 7, 1995 (S. Tharnstrom). Surface tua dominates the left center of the view, with the vegetated inset surfaces appearing adjacent to the active channel. Deposition from the 1995 debris flow appears at right center adjacent to the rapid.

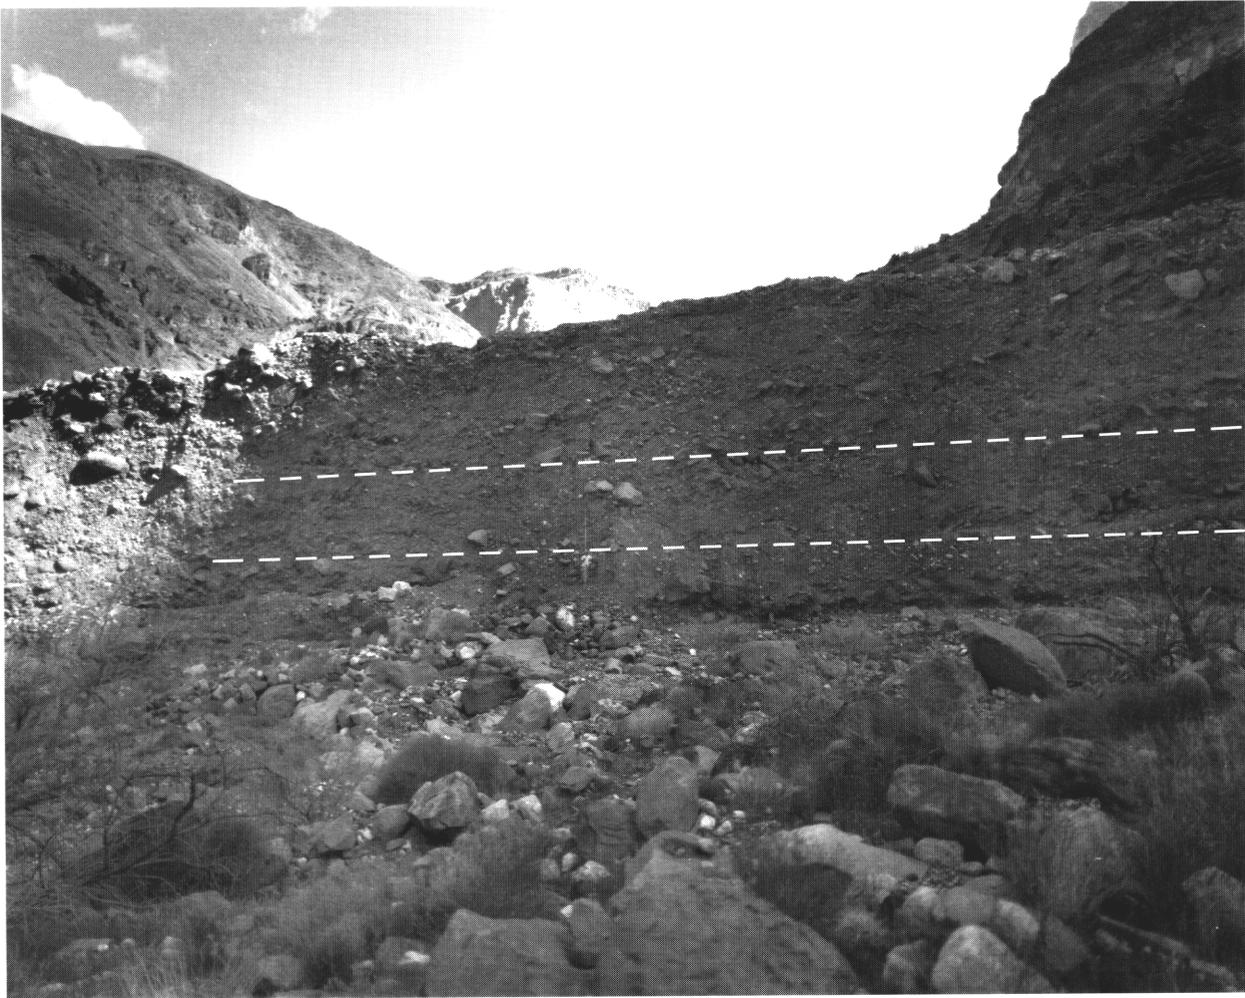
**Figure 8.** View showing the stratigraphy of surface tua (1050 BC) on the Prospect Canyon debris fan. Note the person standing with a stadia rod in the center of the view. Dashed lines indicate the approximate contact points between stratigraphic layers.

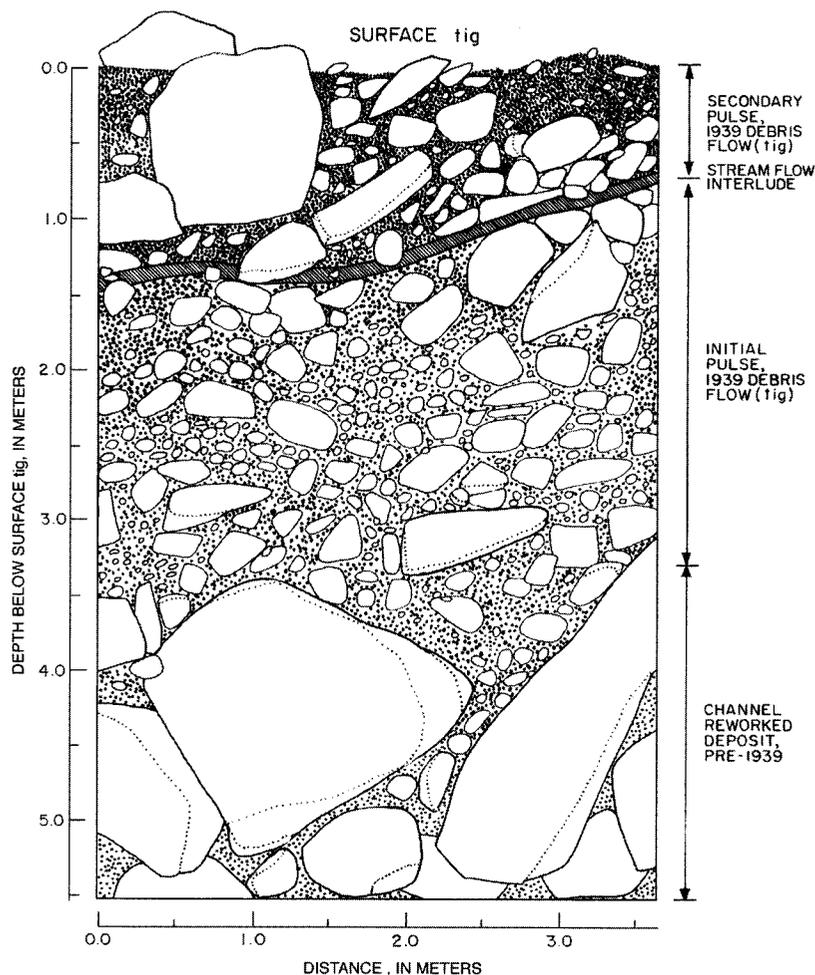
**Figure 9.** Stratigraphy of the 1939 debris-flow deposit (surface tig, pl. 1). A streamflow deposit of reddish silty sand (thin hatched band) is an intermediate phase of the event, separating the initial pulse (1.5-3.5 m) from a secondary pulse (0-1.2 m). The largest boulders at the bottom have b-axis diameters of 0.75-1.4 m.

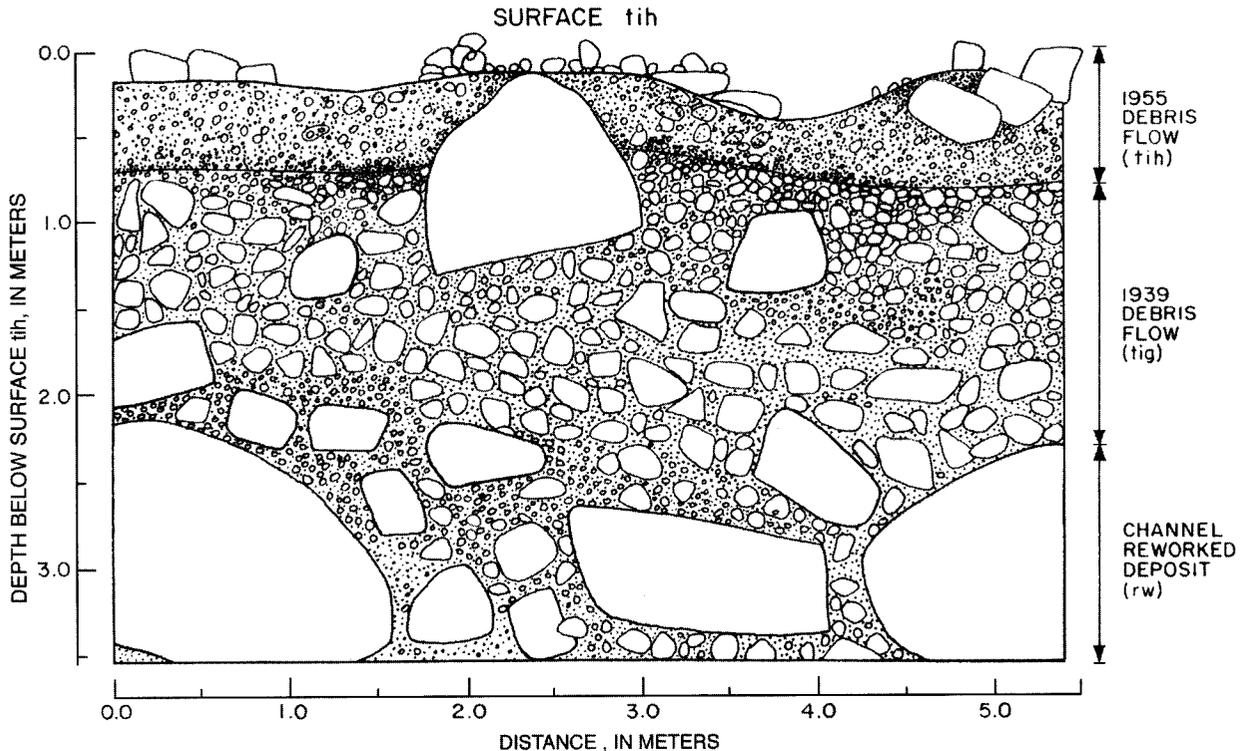
**Figure 10.** Stratigraphy of the 1955 debris-flow deposits (surface tih, pl. 1). The 1955 debris-flow deposit (0.6-1.0 m thick, tih) overlies the surface tig (1939; 0.3-2.0 m thick). Stratigraphic breaks are faint, particularly between the 1939 deposit (tig) and the underlying reworked channel deposits.

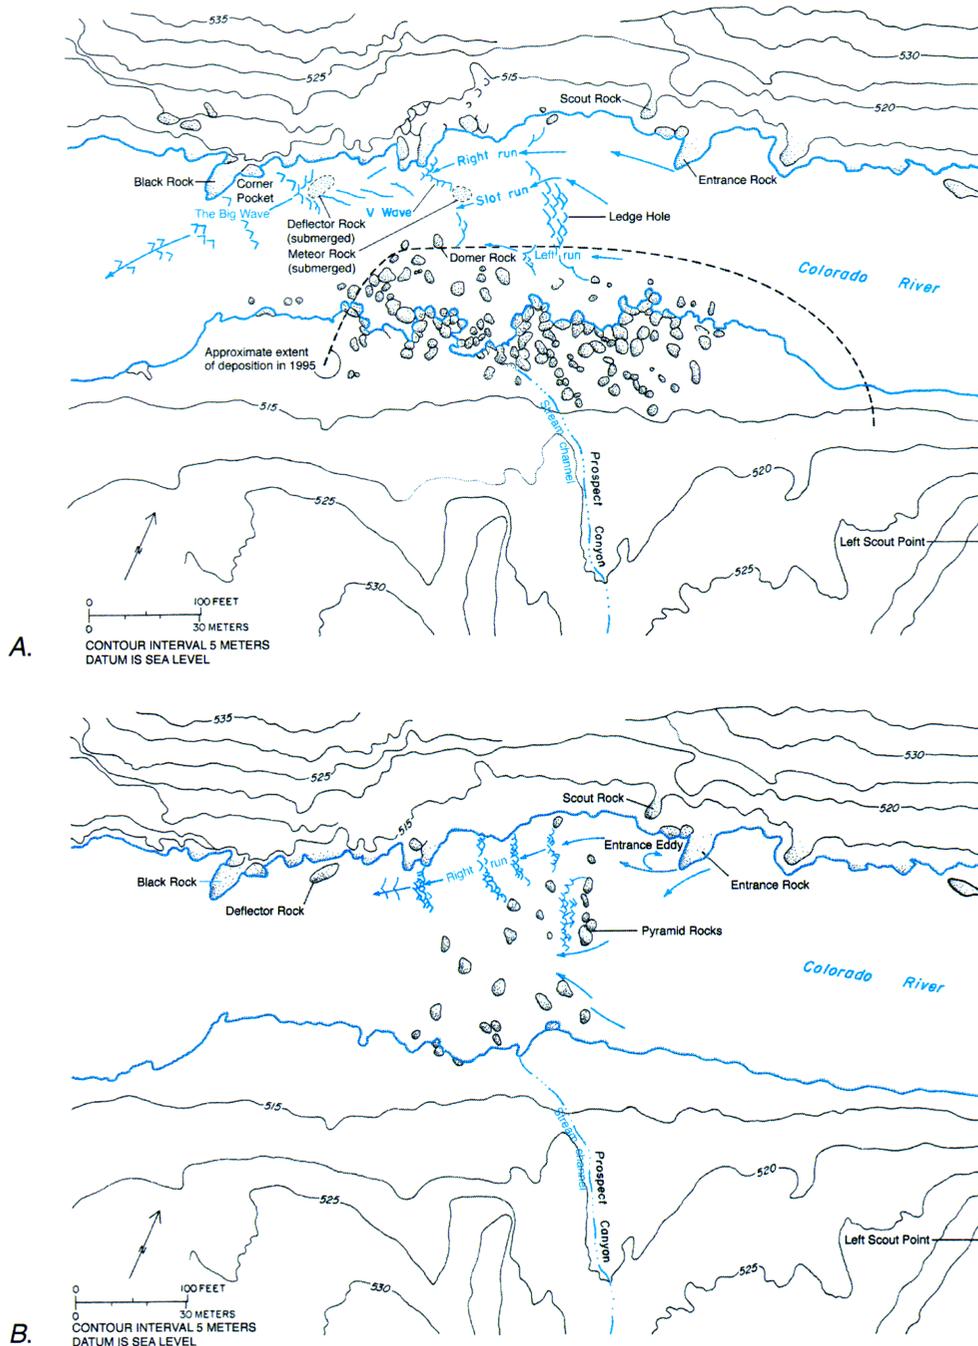
**Figure 11.** Lava Falls Rapid. *A*, Based on a 1994 aerial photograph taken at a discharge of  $234 \text{ m}^3/\text{s}$ , this map shows the modern configuration of Lava Falls Rapid, which was unchanged from 1973 to 1995. The Ledge Hole evolved during the 1950s as boulders accumulated in the center of the rapid. The V Wave is initiated by boulders near the right bank and the Meteor Rock, which probably was deposited in September 1939. The Big Wave forms by flow over the Deflector Rock, which was rotated and moved downstream during the 1939 debris flow. The Right Run, the most common route, is used at discharges less than  $850 \text{ m}^3/\text{s}$ . The Left Run is only feasible at a discharge greater than about  $600 \text{ m}^3/\text{s}$ , whereas the Slot Run is possible from about  $250\text{--}450 \text{ m}^3/\text{s}$ . The 1995 debris flow constricted the rapid by 62 percent, increased the velocity of the Right Run, made the Left Run feasible at lower discharges, and eliminated the Big Wave at most water levels. *B*, The configuration of the rapid from 1872 to 1939 was reconstructed using 37 historical photographs; the water level depicted is about  $280 \text{ m}^3/\text{s}$ . The Pyramid Rocks were prominent near the middle of what is now the entry to the Right Run and were exposed at discharges of less than about  $500 \text{ m}^3/\text{s}$ . The Deflector Rock dominated the right side of the rapid and forced flow to the left of the Black Rock. The left side of the rapid was a series of exposed or shallowly submerged boulders, although a second tongue was present on the left side of the Pyramid Rocks.

Before the 1995 debris flow, river runners used three routes through Lava Falls (fig. 11A). Above about 600 m<sup>3</sup>/s, the Left Run opens adjacent to the left side of the Ledge Hole. At lower discharges, boulders—particularly the Domer Rock—make the left side hazardous. At intermediate discharges (300-600 m<sup>3</sup>/s), the Slot Run, on the right side of the Ledge Hole, is an option that requires a very precise entry. In the era of dam regulation, flows generally are low enough that the Ledge Hole can easily be avoided on the Right Run.

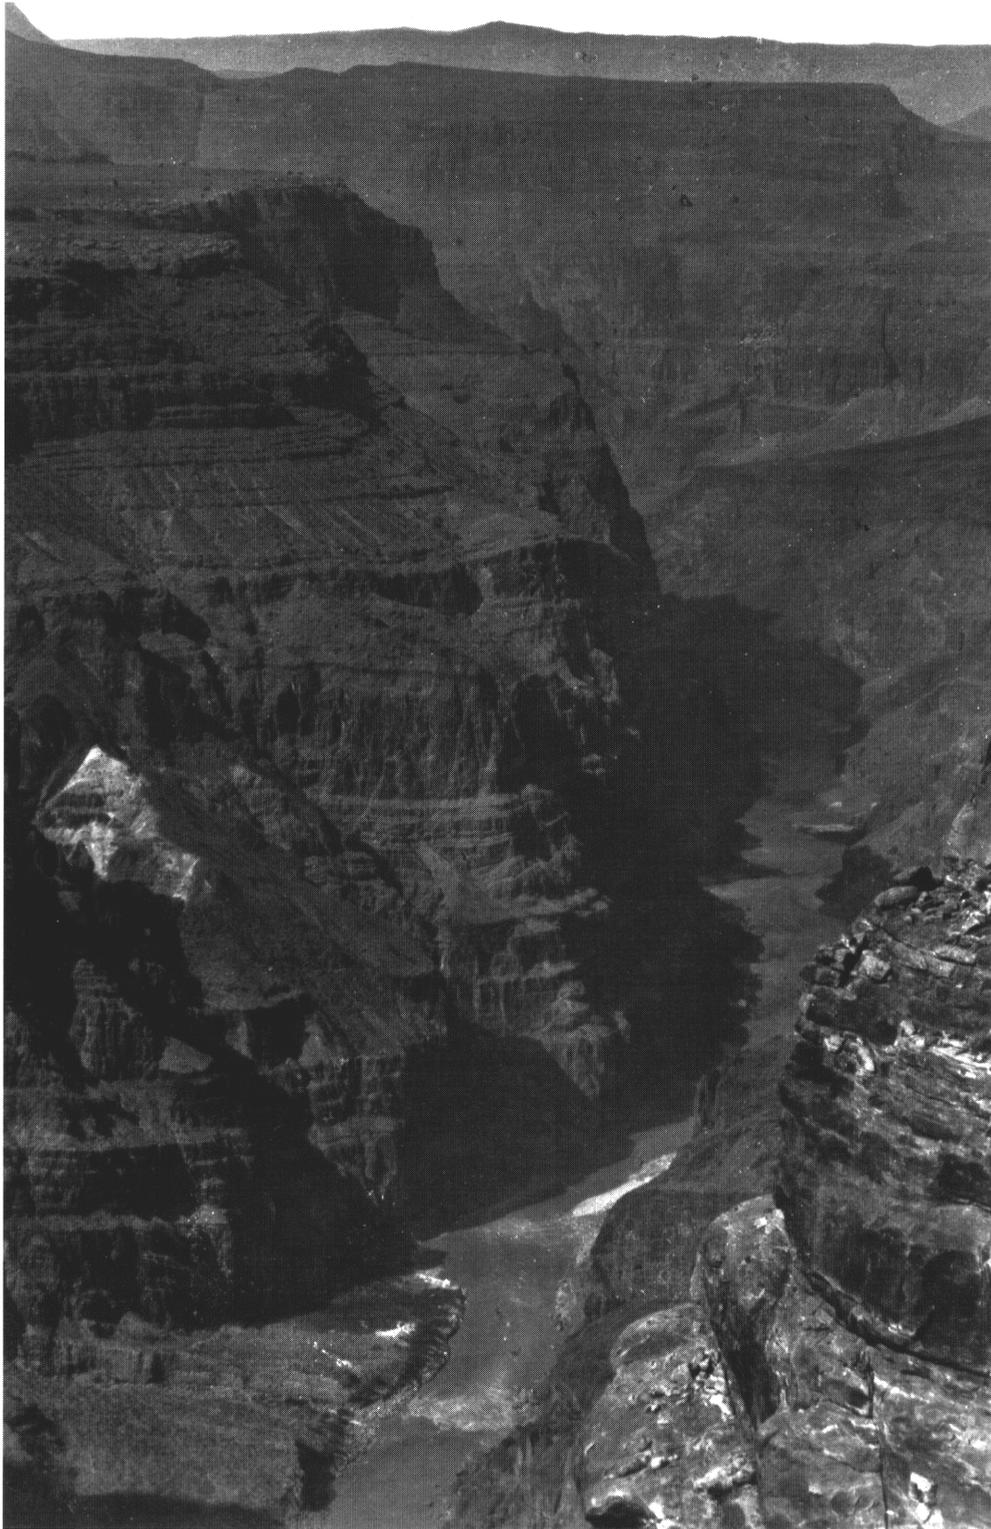
**Figure 12.** Downstream view of Prospect Canyon and Lava Falls Rapid from Toroweap Overlook (Stake 967). A, (April 16, 1872; J.K. Hillers, courtesy of the National Archives). Lava Falls Rapid as viewed by the Powell Expedition was completely different from the rapid now familiar to thousands of whitewater enthusiasts. Using photogrammetric rectification, we found that the rapid began 85 m farther downstream on the left side, and the head of the rapid formed a line perpendicular to flow. A prominent tongue of water entered the left side of the rapid, and its tail waves at the bottom flowed directly downstream. At the discharge shown (approximately  $300 \text{ m}^3/\text{s}$ ), the area of the exposed debris fan is about 0.2 ha.

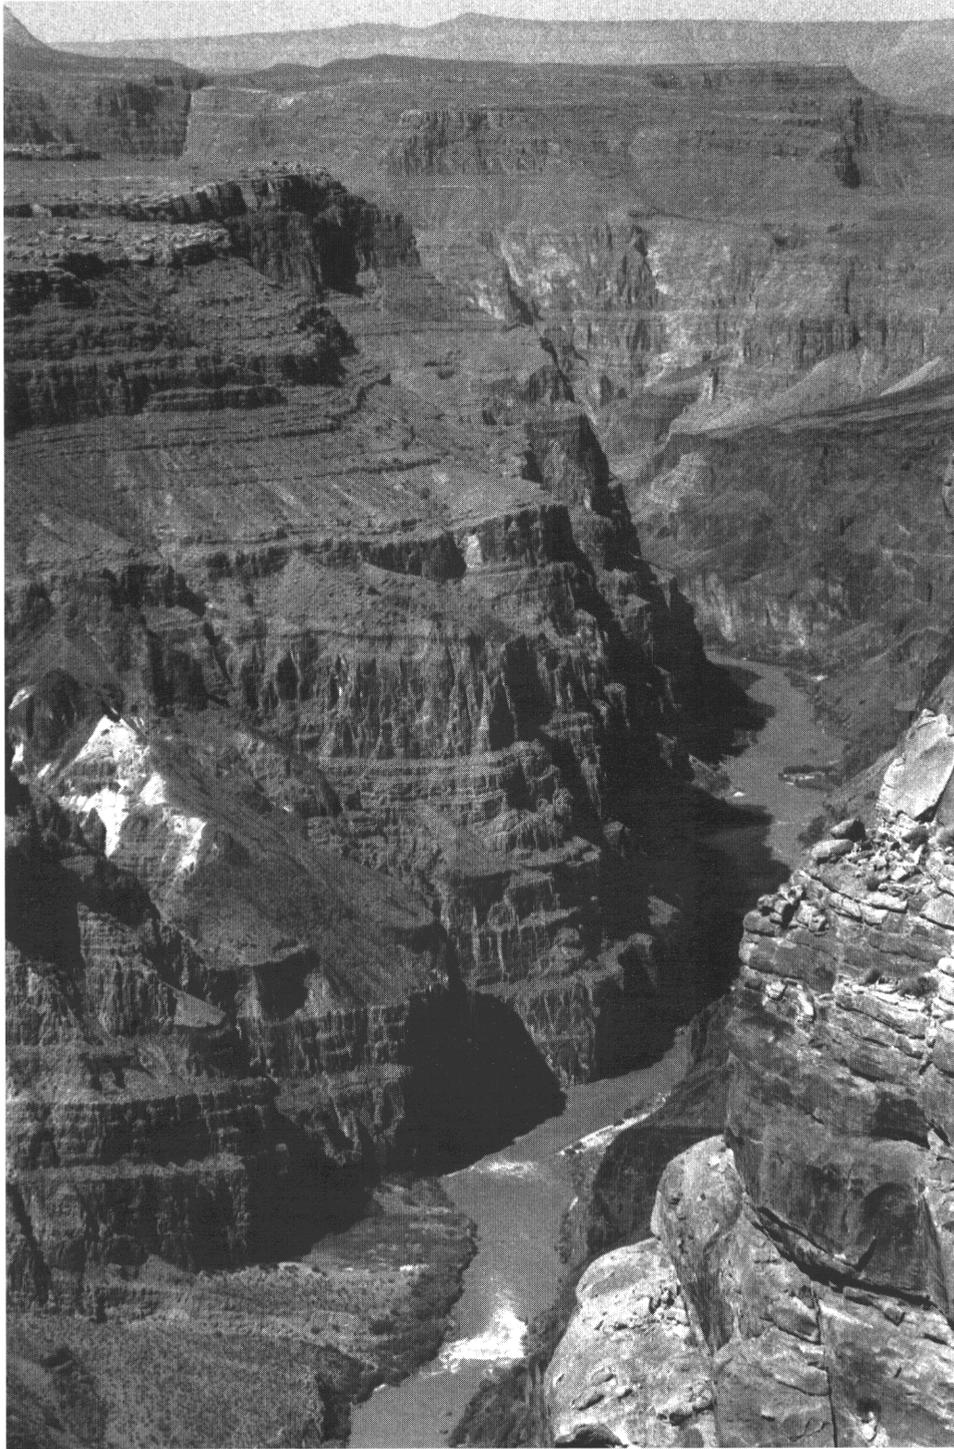
*B*, (June 10, 1979; R.M. Turner). After a series of debris flows from 1939 through 1966, Lava Falls Rapid changed substantially. At a discharge of about  $340 \text{ m}^3/\text{s}$  in 1979, the head of the rapid slanted downstream to the right side, and the main tongue was on the right side. The tail waves were much farther downstream and curved towards the left. Two distinct levees in the mouth of Prospect Canyon were deposited between 1872 and 1966; the largest levee was deposited by the 1939 debris flow, and the smaller, inset levee is remnant channel fill from the 1963 and 1966 debris flows. The debris-flow deposits in the mouth of Prospect Canyon are overgrown with dense riparian vegetation.

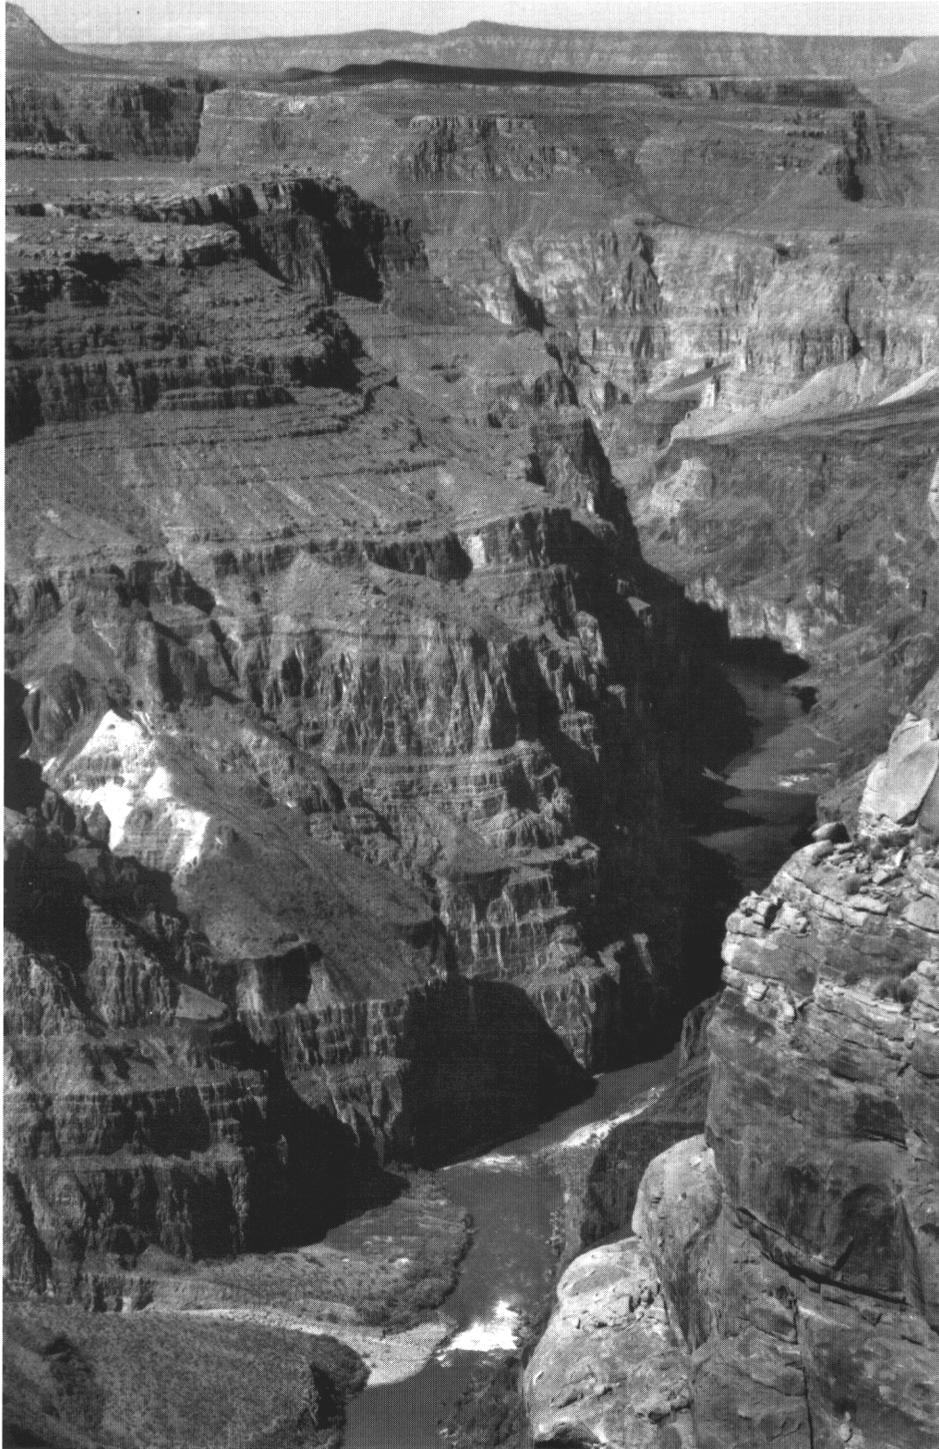
C, (May 16, 1995; R.M. Turner). The debris flow of March 6, 1995, initially constricted the Colorado River by 62 percent, but reworking quickly widened the river and reduced the constriction, as shown here, to about 50 percent. The constriction increased the drop through Lava Falls Rapid, accentuating its hydraulics, but some formerly prominent waves, such as the Big Wave, were not present. The 1963 and 1966 debris-flow deposits were completely eroded from the margins of Prospect Canyon. At this discharge of about  $260 \text{ m}^3/\text{s}$ , the exposed area of the new debris fan is 0.62 ha.

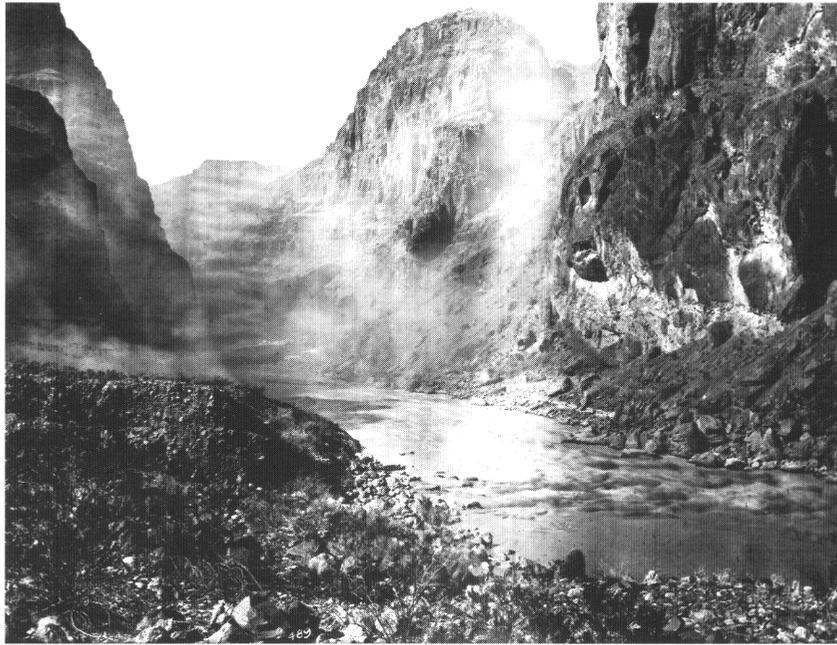
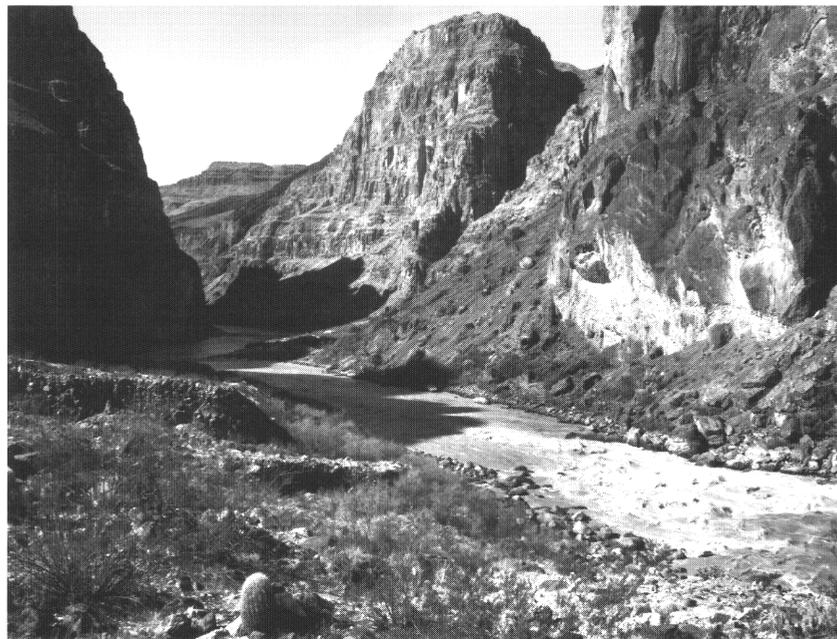
**Figure 13.** Downstream view of Lava Falls Rapid from the high surface on the left side (Stake 1510b). The channel of Prospect Canyon, which enters the Colorado River from the left, appears in the center of the view. A, (February 27, 1890; R. B. Stanton, courtesy of the National Archives). The last vestiges of smoke from a large fire set by the Stanton expedition are shown at left center. The left side of the rapid has flat, relatively slow-moving water adjacent to the mouth of Prospect Canyon. The Deflector Rock is visible on the right side approximately 15 m upstream from the Black Rock. Tail waves from the rapid are deflected away from the Black Rock and the main flow is down the center of the rapid. The water level is 280-400 m<sup>3</sup>/s. B, (February 11, 1990; R. M. Turner). Debris flows from Prospect Canyon changed the rapid substantially in the 20th century. The rapid now begins farther upstream. The 1939 debris flow deposited the prominent low surface at left center. Deposition during the 1939 event forced flow through the rapid to the right; the Deflector Rock moved downstream and was submerged at most water levels. The Black Rock deflects typical dam releases to the left. Debris flows in 1954, 1955, 1963, and 1966 deposited sediment along the left side of the rapid, changing a relatively quiescent area to whitewater choked with boulders.

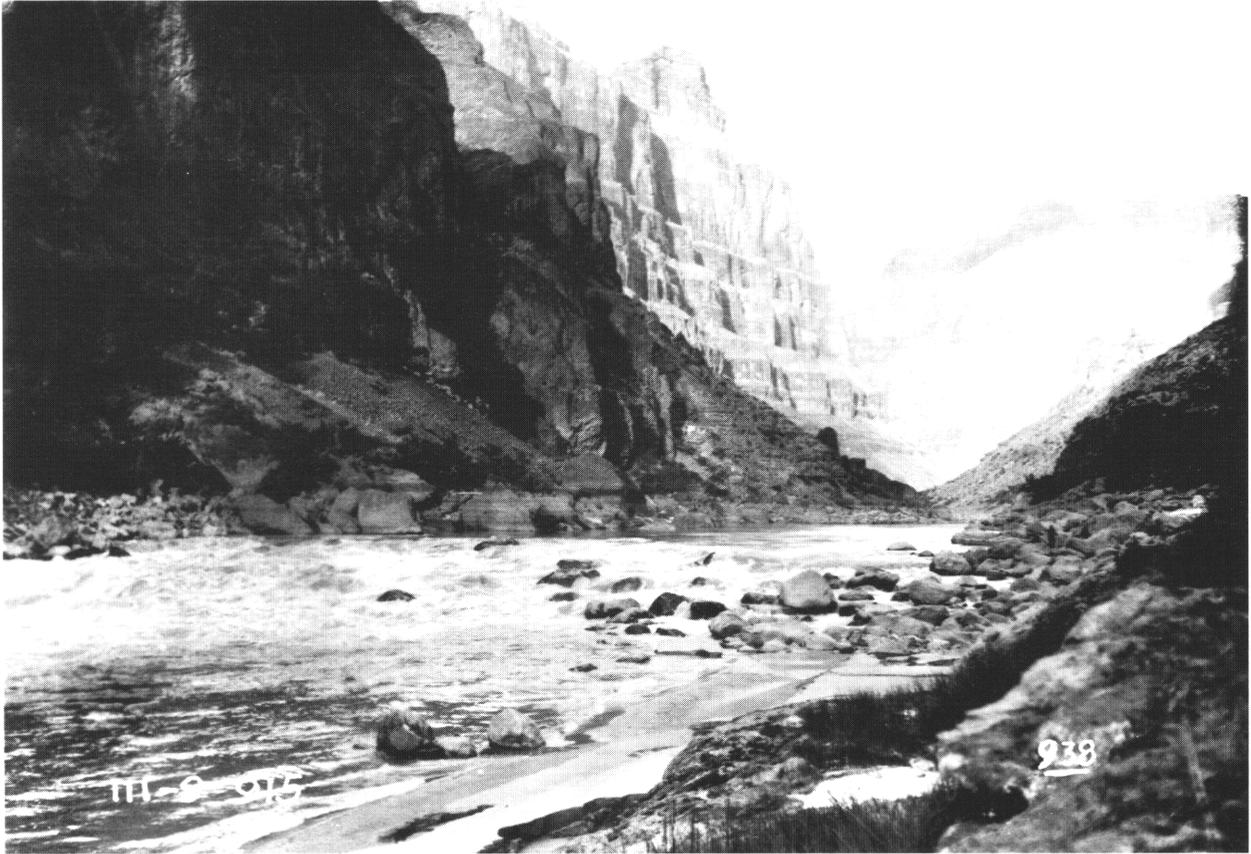
**Figure 14.** Upstream view of Lava Falls Rapid from the left side (November 10, 1909; R. Cogswell, courtesy of the Bancroft Library, University of California at Berkeley). Boulders that appear on the debris fan and in the river in this view also appear in views taken by Hillers (1872) and Kolb (1912). Photographs taken in 1923 and 1927 show the same boulders, which demonstrates the stability of the rapid in floods of at least  $6,200 \text{ m}^3/\text{s}$ .

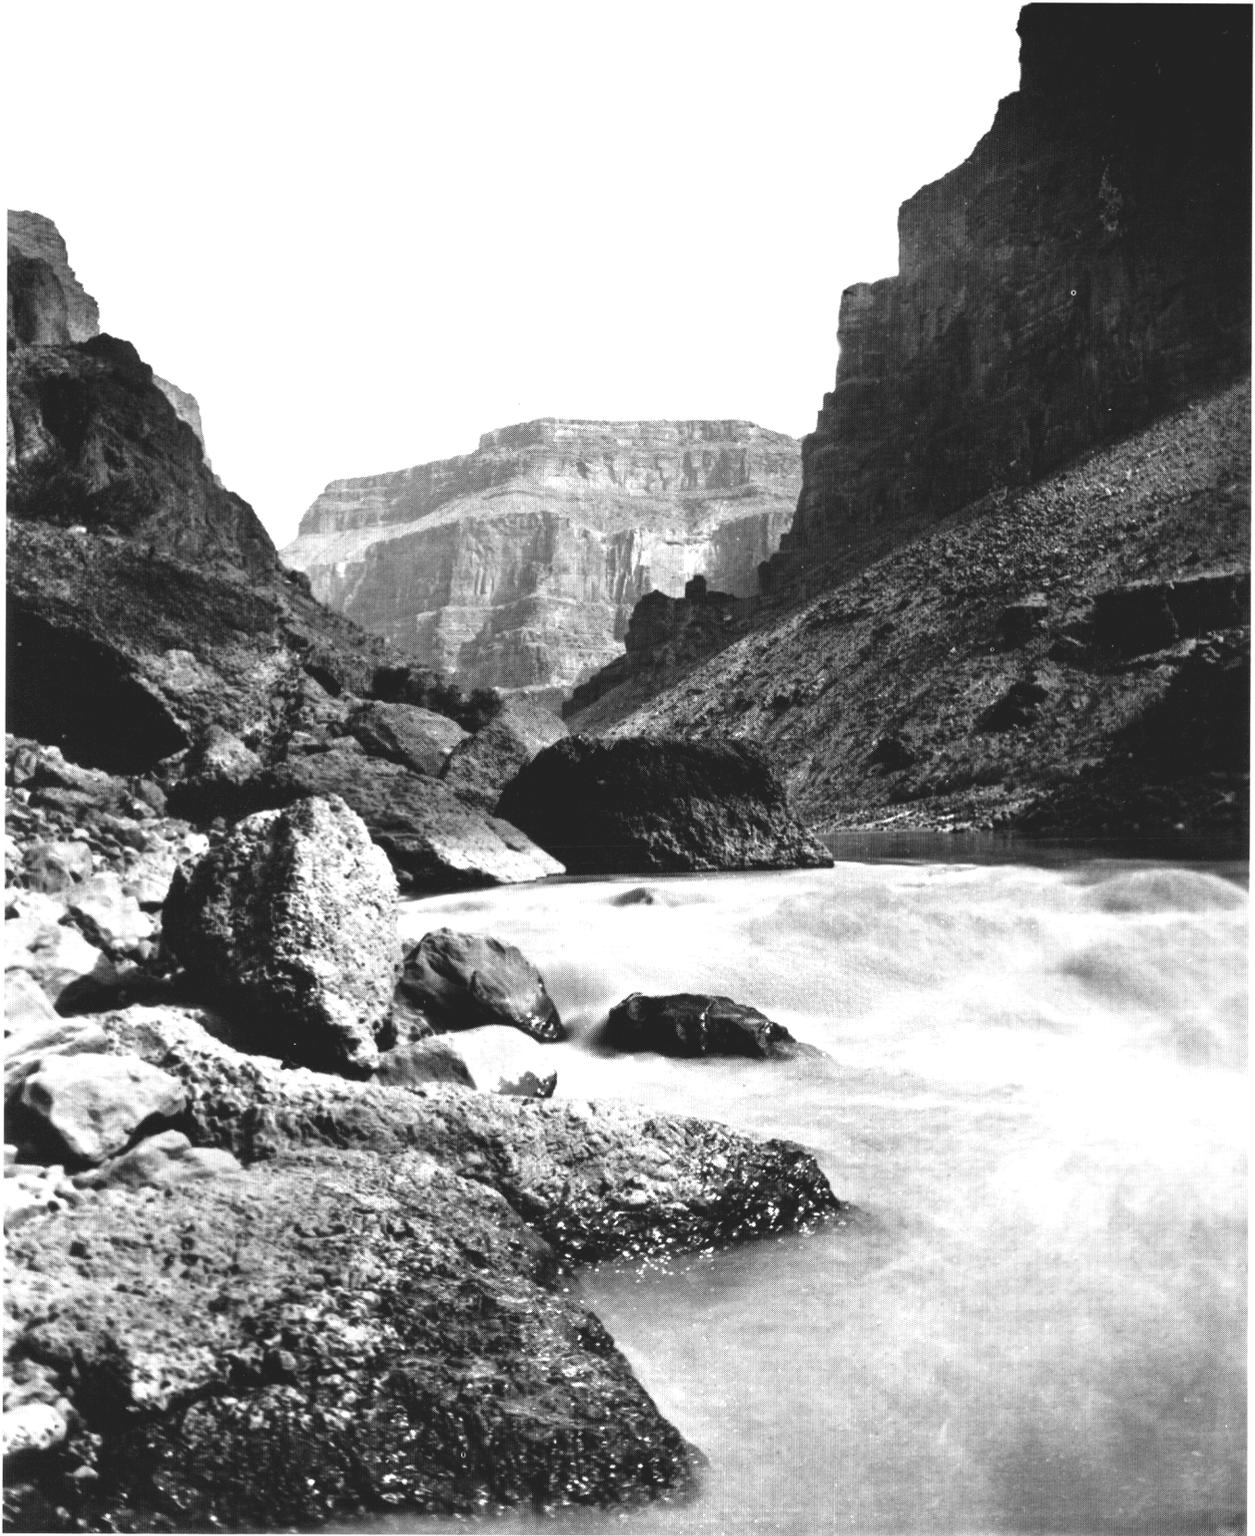
**Figure 15.** Upstream views of the head of Lava Falls Rapid from the right side (Stakes 2598 and 2662). A, (April 19, 1872; J.K. Hillers, courtesy of the National Archives). At a discharge of about  $280 \text{ m}^3/\text{s}$ , the Entrance Rock appears in the center; the Entrance Eddy is behind this rock, and the first hole that Buzz Holmstrom, Don Harris, and Bert Loper had to run in 1938 and 1939 appears at lower right. Many rocks and small pourovers are visible in the center of the photograph. This photograph is also shown in Graf (1979).

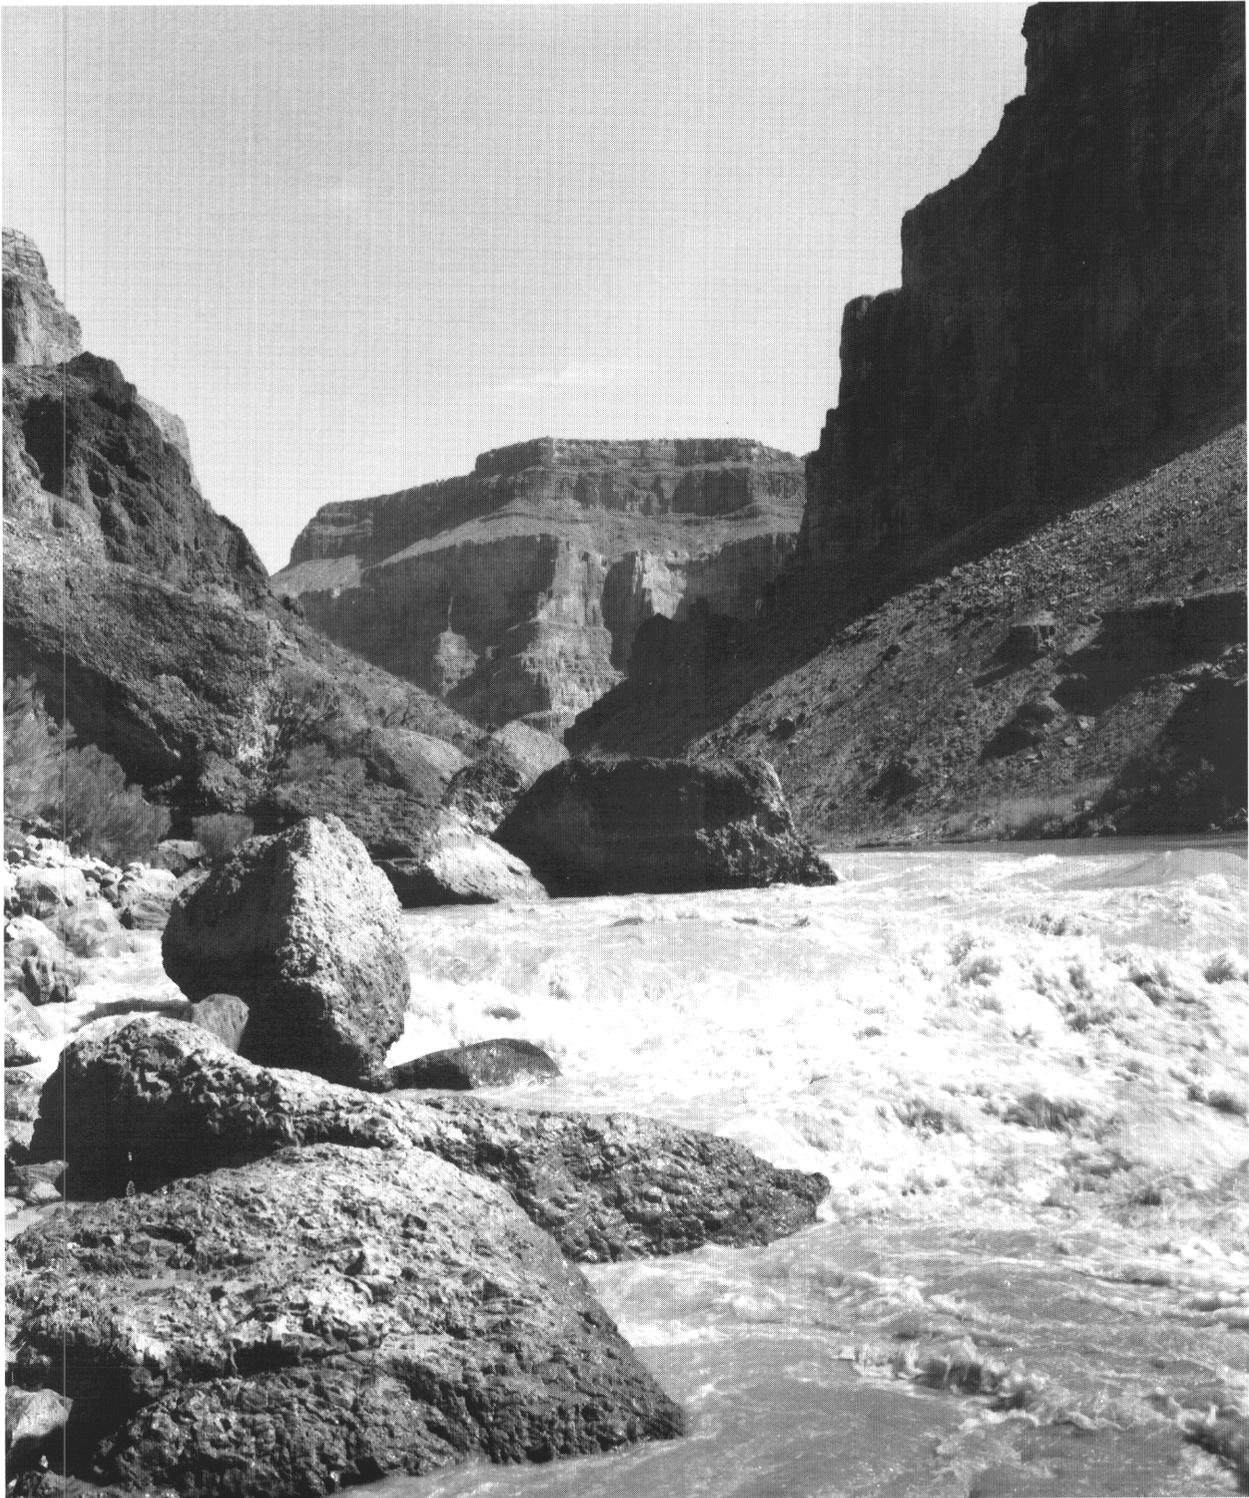
*B*, (March 8, 1993; L. Hymans). Even though flow in the Colorado River ( $310\text{--}340\text{ m}^3/\text{s}$ ) is only slightly higher, the stage appears much higher than in 1890. A turbulent eddy forms behind the Entrance Rock. Now, rocks or pourovers are not visible above  $140\text{ m}^3/\text{s}$ . Also, water flows around the right side of the large basalt boulder in the center of the view.

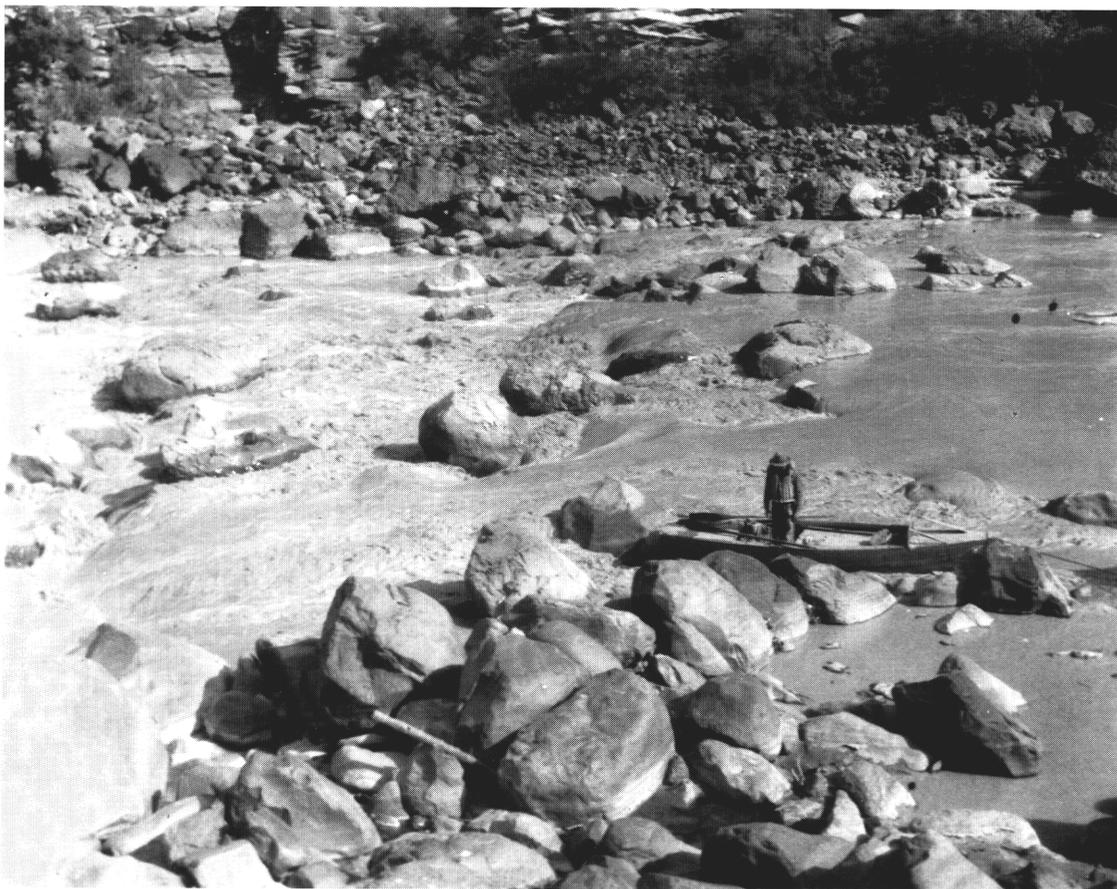
**Figure 17.** View of Lava Falls Rapid from the left side (July 31, 1934; B. Fahrni, courtesy of the Utah State Historical Society. All rights reserved. Used by permission.). The crew of the 1934 Frazier-Hatch expedition are lining boats to the head of the rapid to begin a portage. The discharge was 60 m<sup>3</sup>/s, one of the lowest summer levels recorded in the 20th century, and the boulders that form the rapid protrude from the water. The Pyramid Rocks are visible at the upper right of the view. Many of the boulders shown in this view were dislodged or buried by the 1939 debris flow. After 1957, the Ledge Hole formed downstream from the boulders visible in this 1934 view.
