# **Lava Falls Rapid in Grand Canyon: Effects of Late Holocene Debris Flows on the Colorado River**

**Professional Paper 1531**

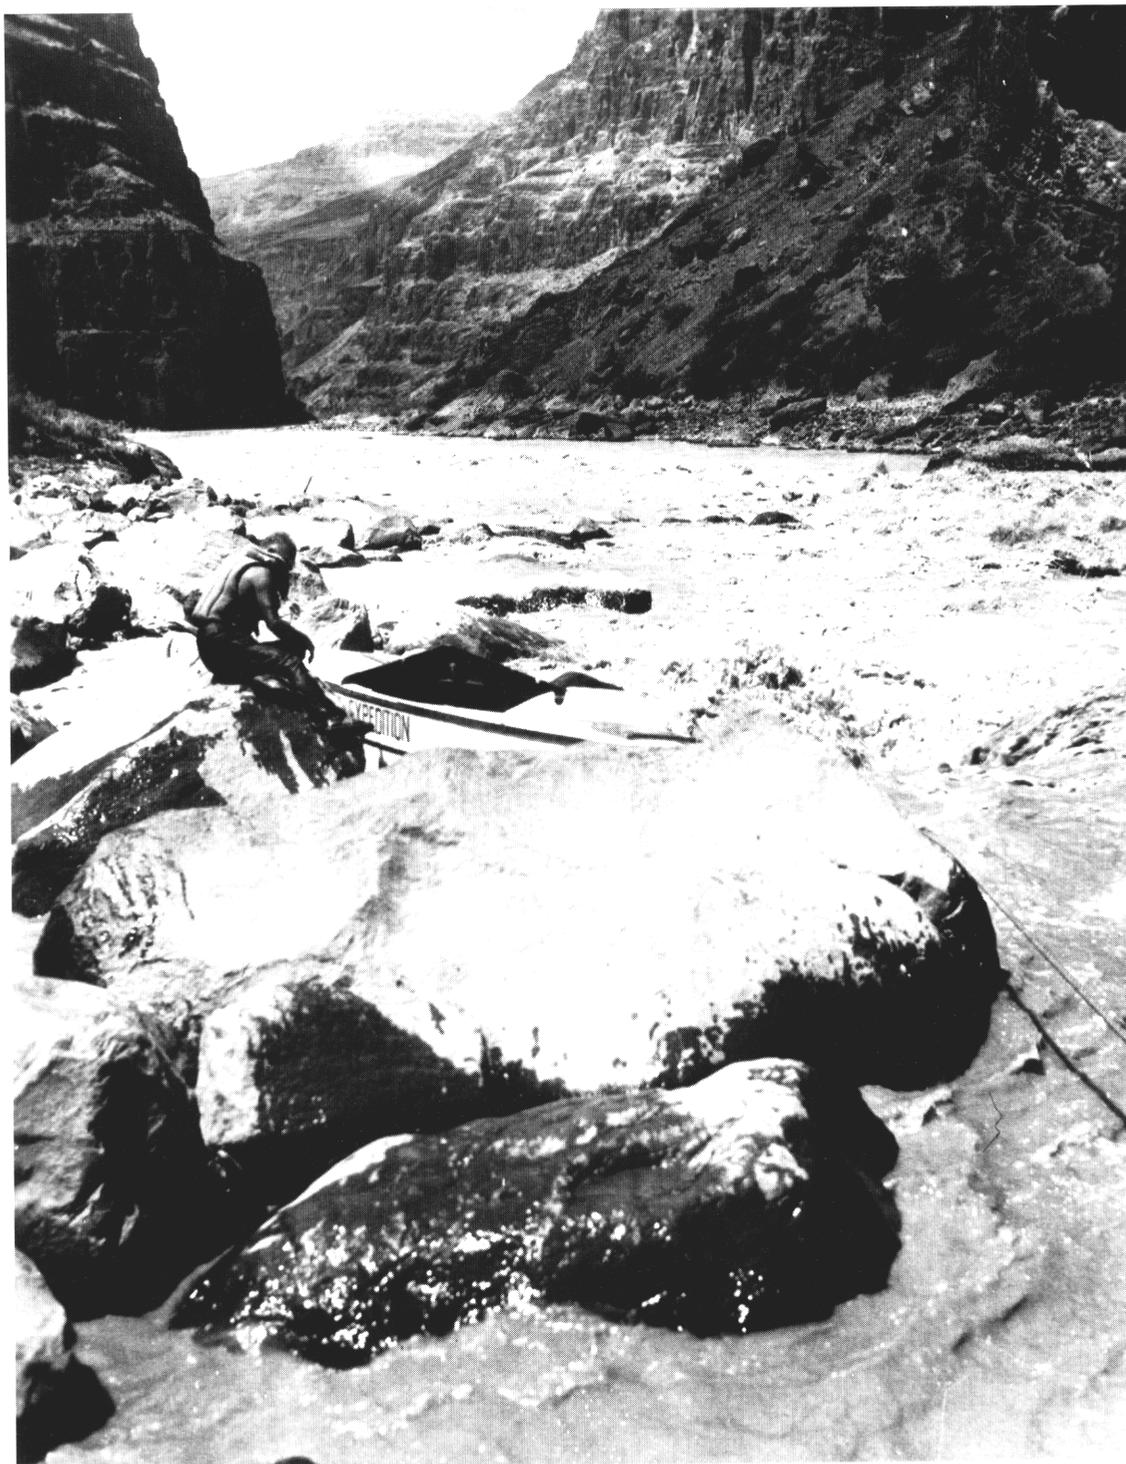
**Figure 19.** Downstream view of Lava Falls Rapid from the left side (Stake 2741). A, (July 27, 1941; W. Heald, courtesy of the University of Utah Marriott Library). A crew member of the 1941 Nevills expedition rests on a rock during a portage down the left shore. At a discharge of about  $570 \text{ m}^3/\text{s}$ , water is piling up against the Black Rock, shown in the upper right of the view. The pattern of the tail waves, which has changed in comparison to pre-1939 views, is the result of increased constriction of the Colorado River and displacement of the Deflector Rock during the 1939 debris flow. All foreground rocks in this photograph were deposited in 1939.

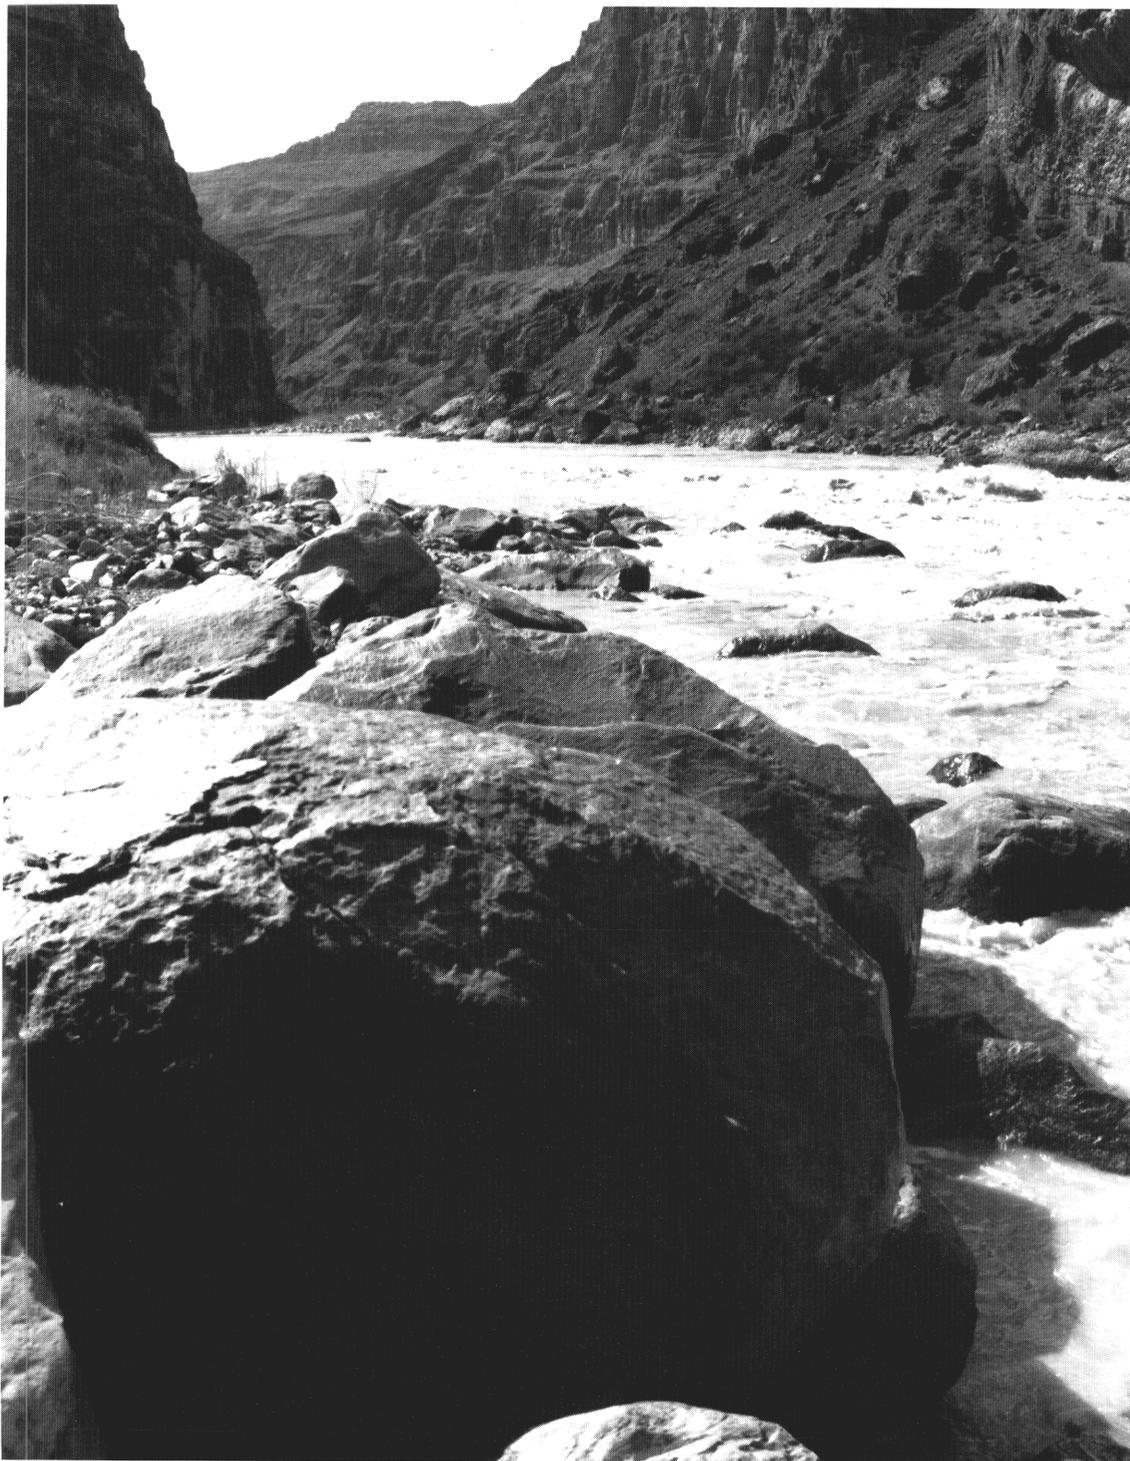
*B*, (March 10, 1993; S. Tharnstrom). Flow in the Colorado River is about 230–280 m<sup>3</sup>/s. Although many boulders have been transported in and out of the field of view by debris flows after 1941, several boulders in the midground remain. The boulder that the Nevills' crew member is resting on in 1941, as well as the boulders immediately upstream, are in the same place. The foreground boulder, which has a b-axis diameter of 1.85 m, was probably deposited during the 1955 debris flow. The pattern of waves at the bottom of Lava Falls Rapid is similar in 1941 and 1993.

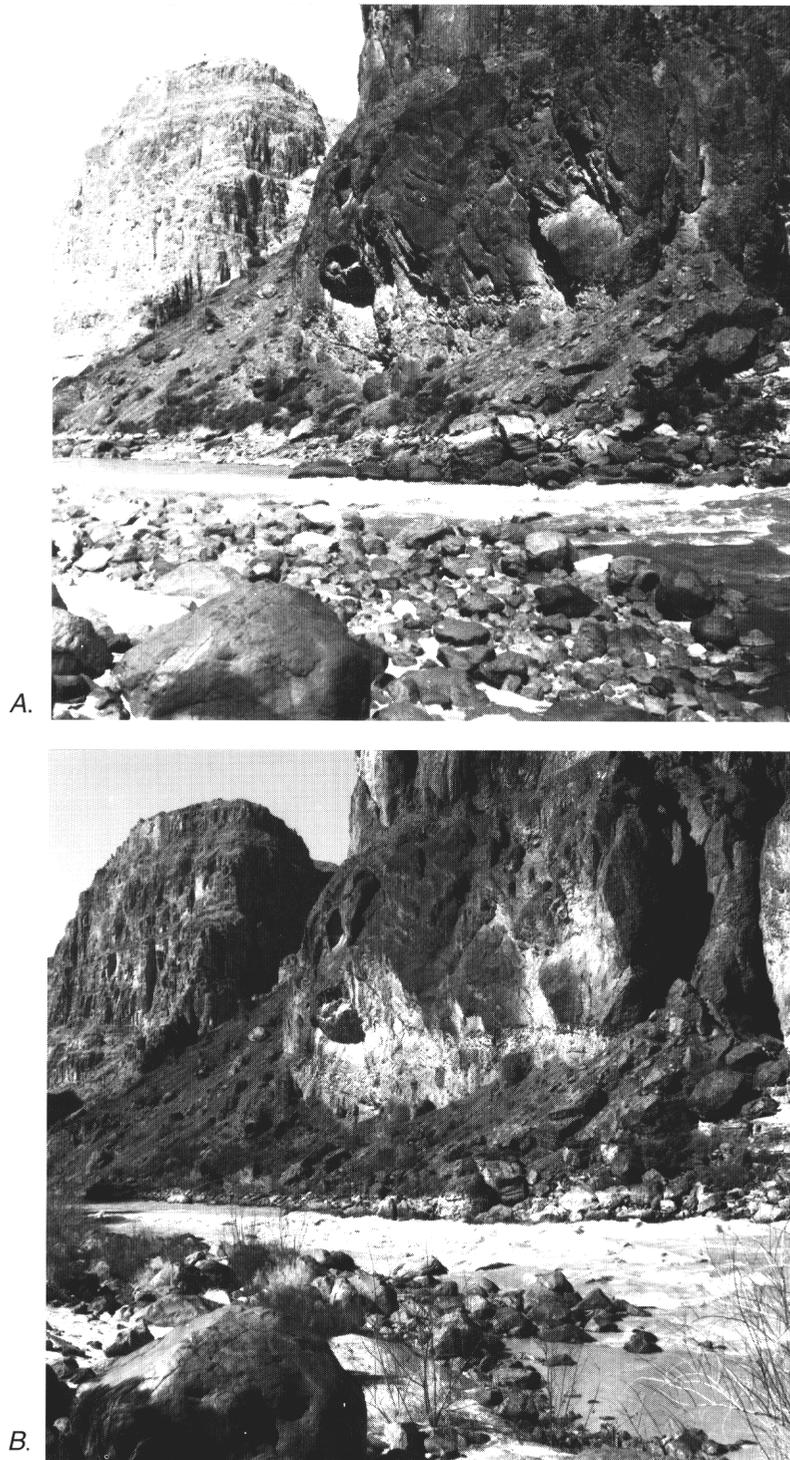
**Figure 22.** Downstream view of Prospect Canyon debris fan and the tailwaves of Lava Falls Rapid (Stake, 2002). *A.* (July 20, 1958; G. Staveley, courtesy of the Huntington Library). The discharge is  $220 \text{ m}^3/\text{s}$ , and the boulders on the debris fan are the net result of the 1939, 1954, and 1955 debris flows and subsequent reworking by the Colorado River. The 1957 flood in the Colorado River reworked the deposits of the 1954 and 1955 debris flows. *B.* (February 20, 1991; D. Edwards). Although the stage was about 0.5 m higher than in the 1958 view, 6–10 boulders with diameters of 1 m or larger remain. Most of the foreground debris fan was buried by debris flows in 1963 and 1966 and was subsequently re-exposed. The debris fan decreased in size slightly between 1958 and 1991 although the size of boulders in the reworked zone appears unchanged.

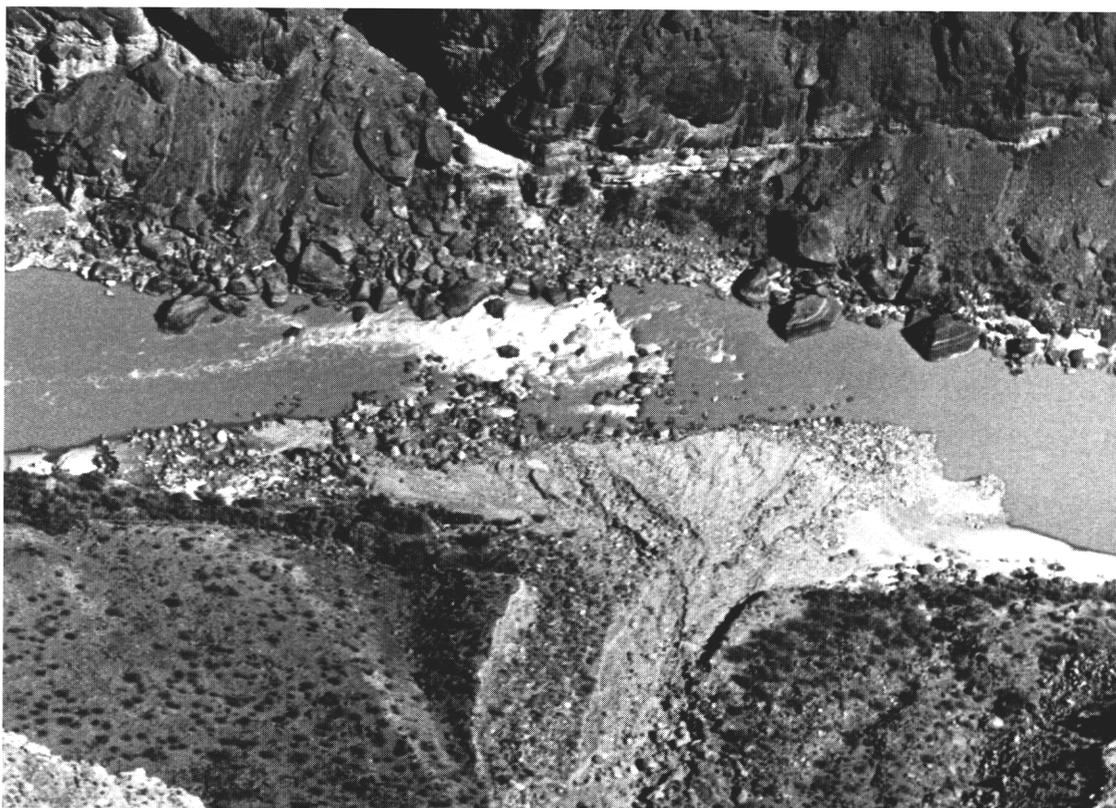
**Figure 24.** Oblique aerial view of Lava Falls Rapid and Prospect Canyon (May 20, 1964; P. T. Reilly). At a discharge of  $37 \text{ m}^3/\text{s}$ , the 1963 debris-flow deposit constricts the river by about 60 percent; the debris fan initially extended nearly to the middle of the Ledge Hole. This view shows the reworking by a peak discharge of  $540 \text{ m}^3/\text{s}$ . The Meteor Rock is visible in the center of the rapid, and the usually submerged Deflector Rock divides the tail waves.

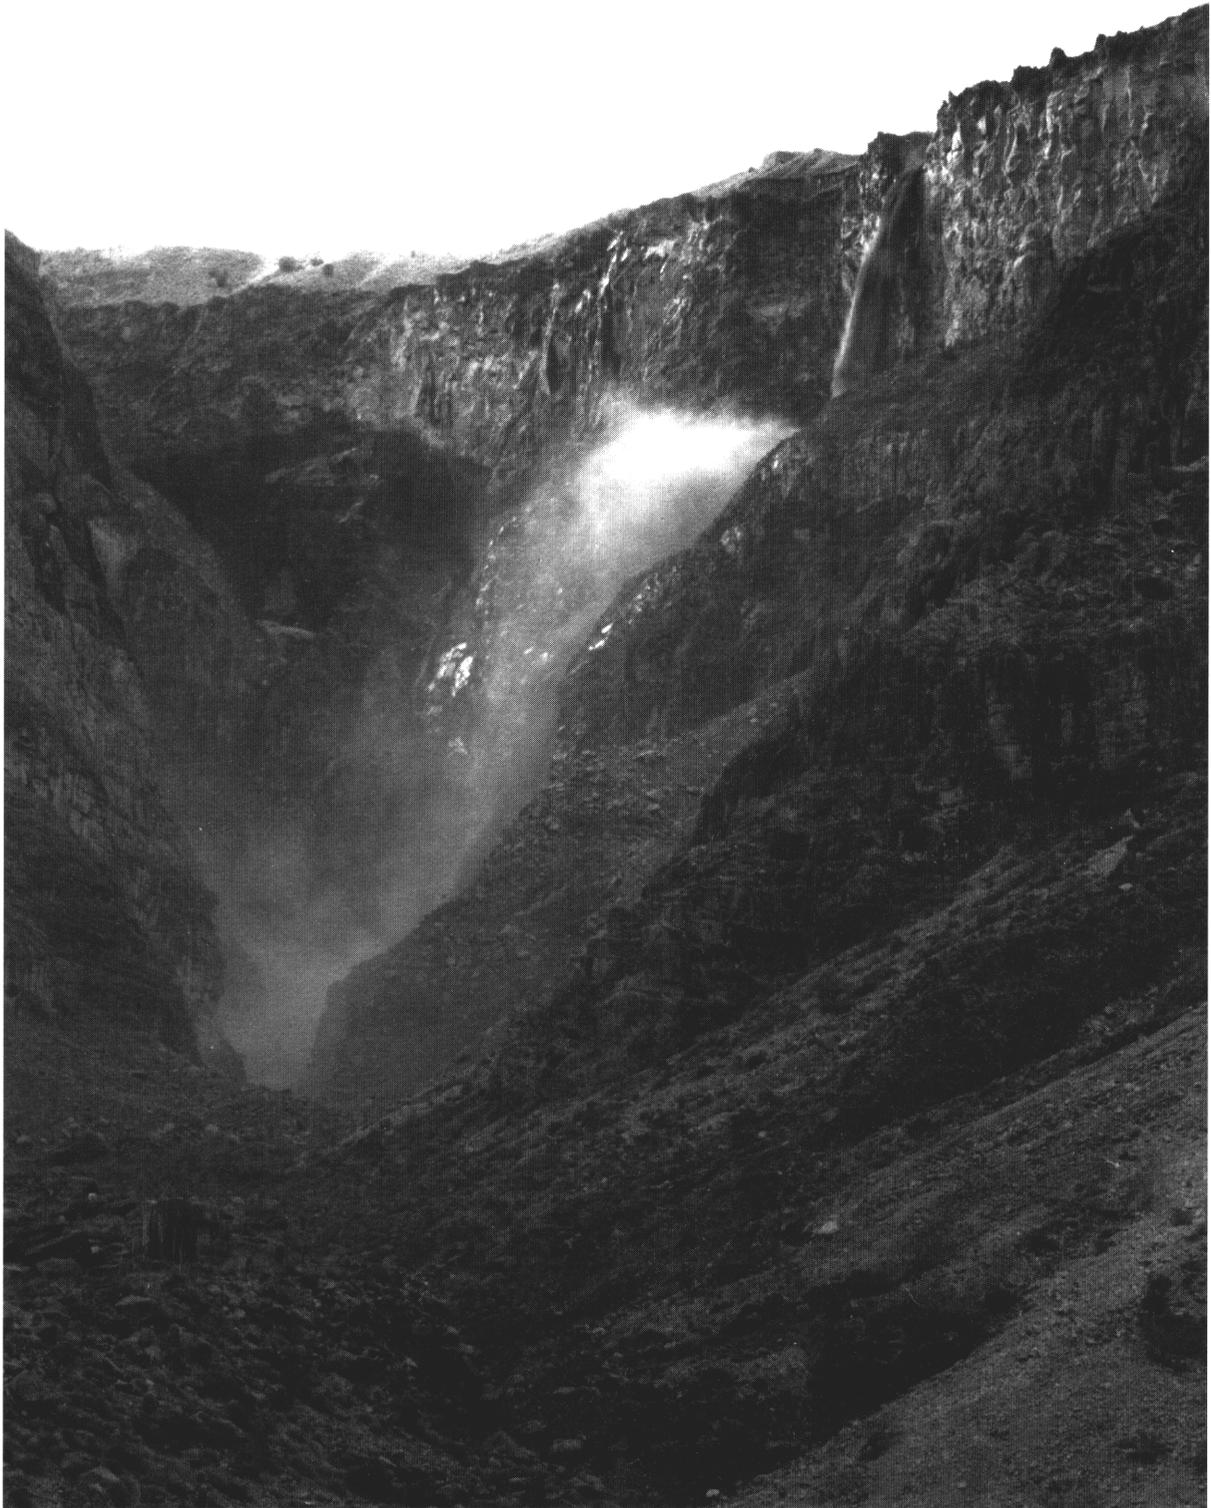
**Figure 27.** (March 6, 1995; S. Tharnstrom). The firehose effect created by streamflow falling over a 325-m fall at the head of Prospect Canyon on March 6, 1995.

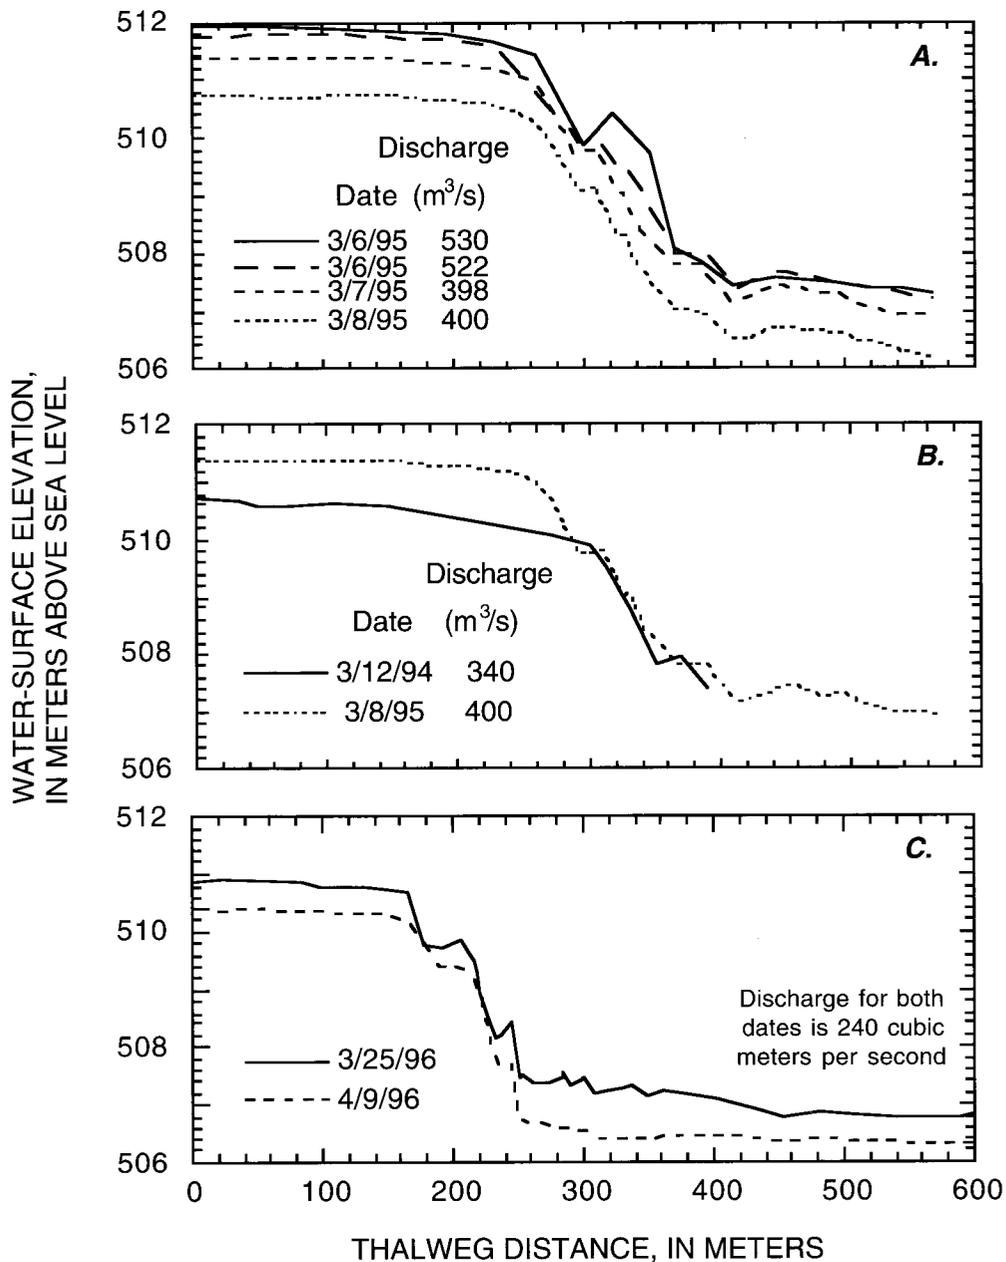
**Figure 29.** Longitudinal profile of the water-surface fall on the right side of Lava Falls Rapid. *A*, Changes in water-surface profile after the 1995 debris flow. *B*, Comparison of water-surface profiles in March 1994 and March 1995. *C*, Comparison of water-surface profile as a result of the 1996 controlled flood.

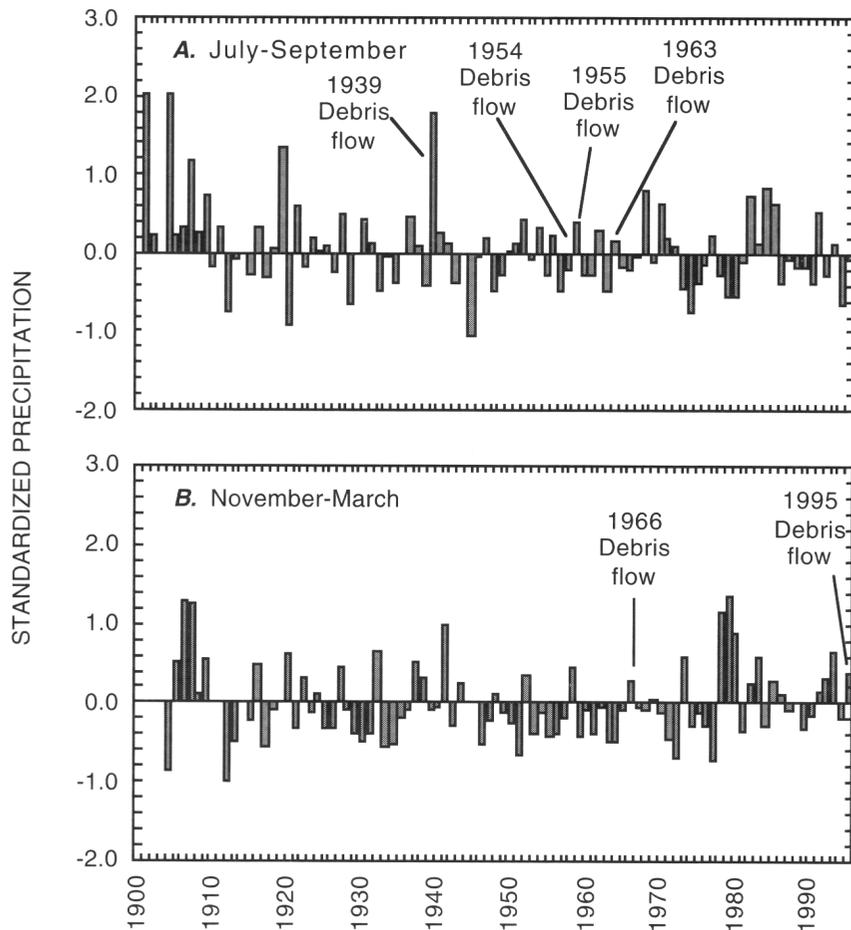
**Figure 30.** Standardized seasonal precipitation for eight stations in the vicinity of western Grand Canyon (table 4). Seasonal precipitation is converted to a time series with mean = 0 and variance = 1; positive values represent above average precipitation. Negative values represent below-average precipitation. A, Summer (July-September) precipitation. B, Winter (November-March) precipitation.

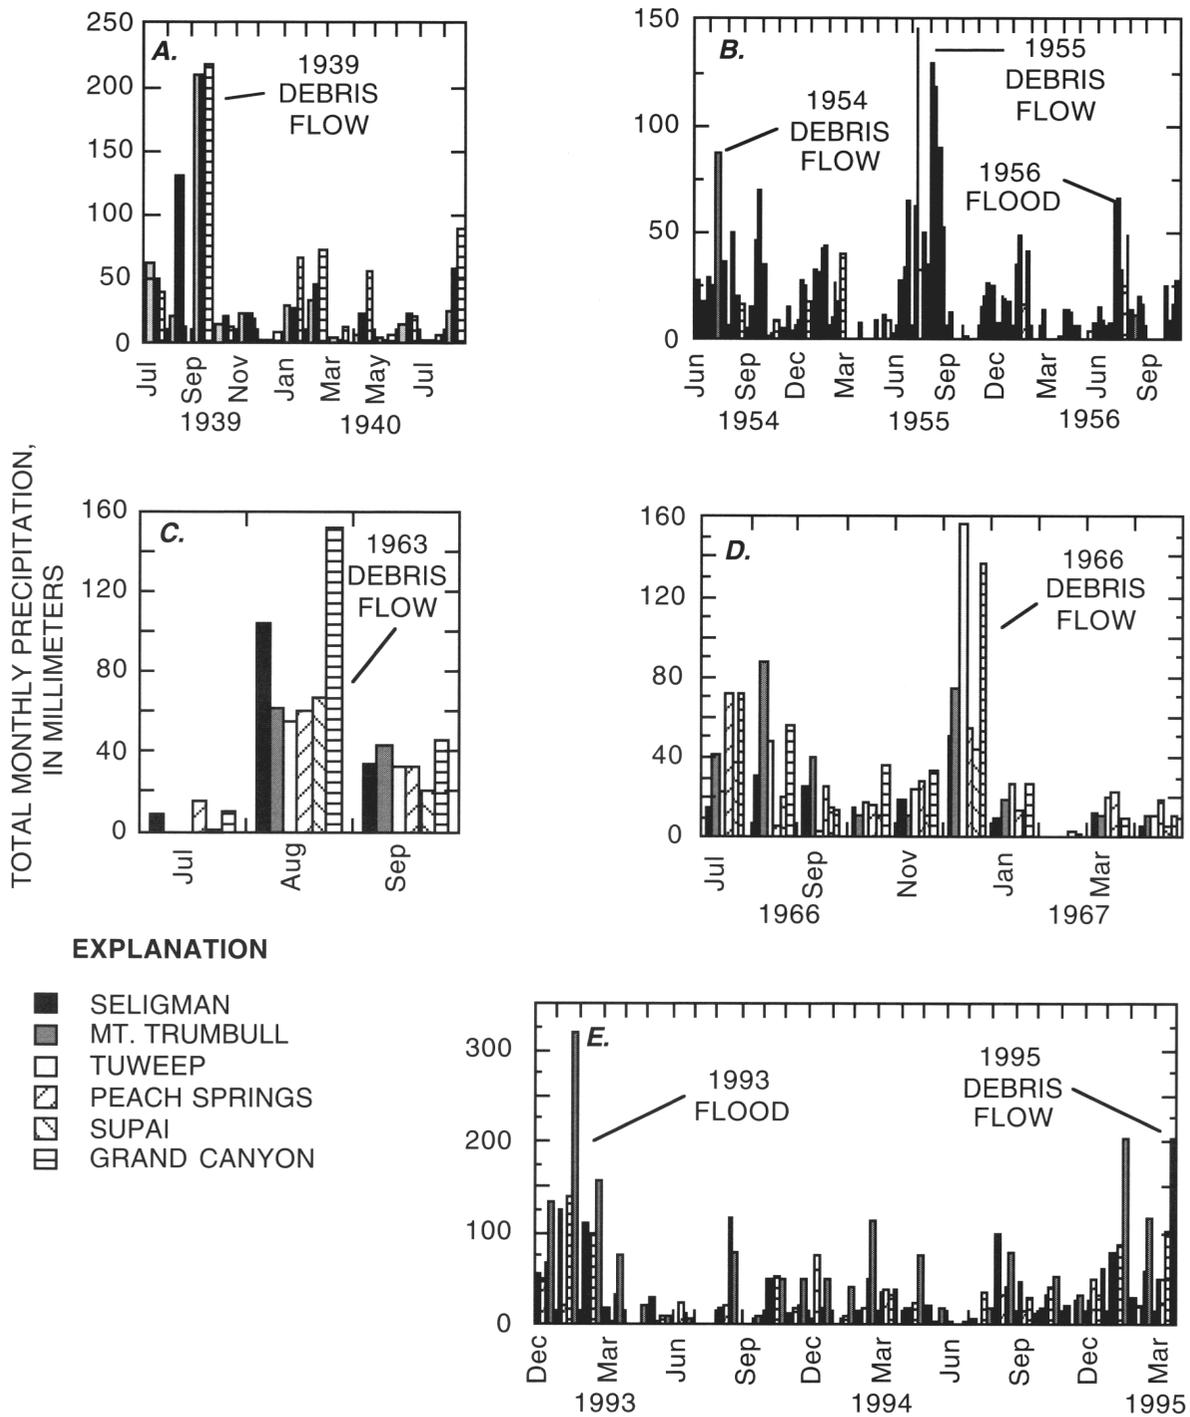
**Figure 31.** Monthly precipitation near the Prospect Valley drainage basin associated with Prospect Canyon debris flows and floods. *A.* July 1939 to August 1940. *B.* June 1954 to October 1956. *C.* July to September 1963. *D.* July 1966 to April 1967. *E.* December 1992 to March 1995.

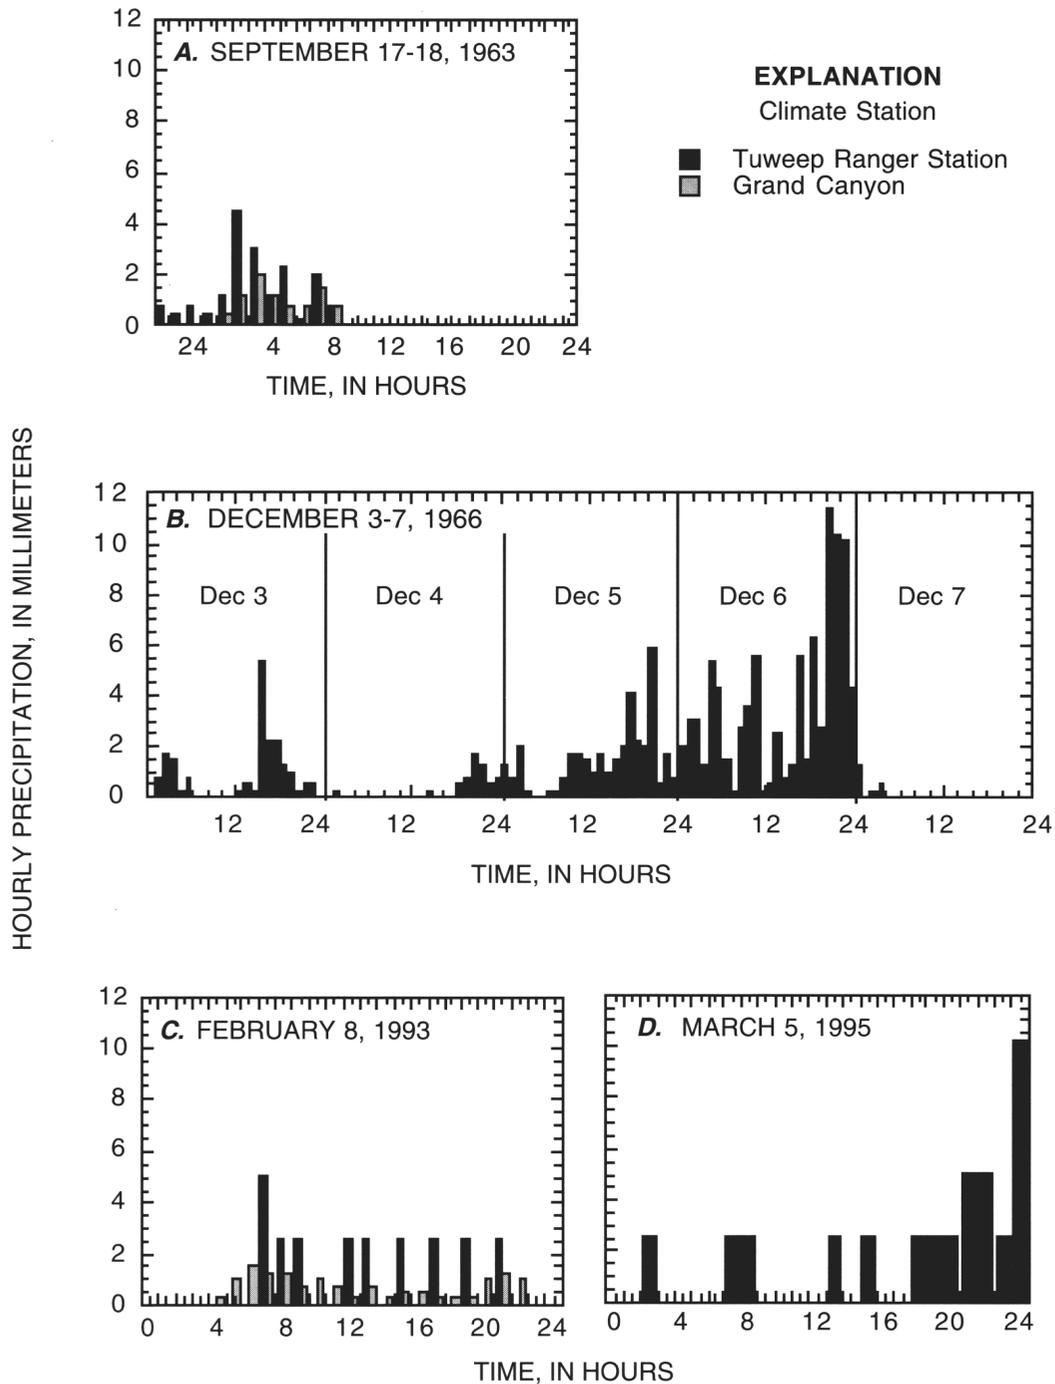
**Figure 32.** Hourly precipitation at Tuweep Ranger Station and Grand Canyon during three historical debris flows and one flood in Prospect Canyon. *A*, September 1963. *B*, December 1966. *C*, February 1993 (streamflow flood). *D*, March 1995.

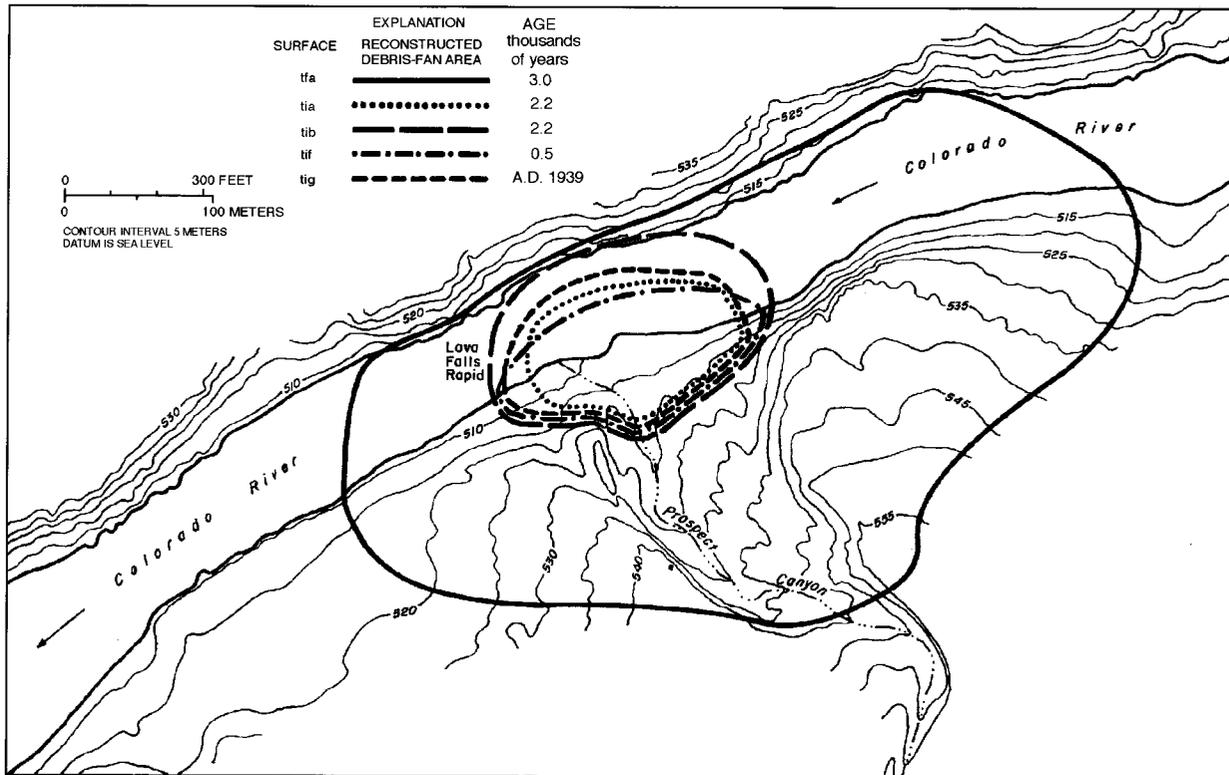
**Figure 33.** The spatial extent of five debris fans deposited by Holocene debris flows from Prospect Canyon. The location of the edge and the thickness of the debris fan were determined by projection into the river from remnant deposits (table 9).

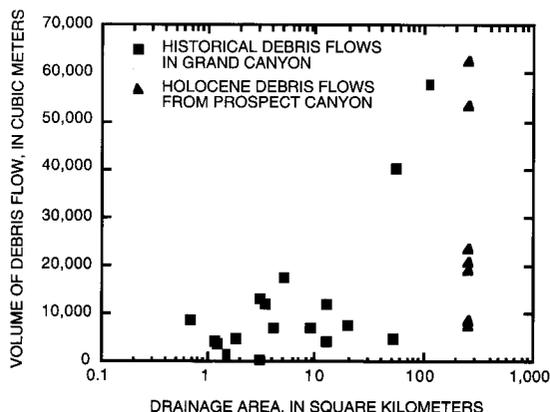
**Figure 34.** The volume of sediments deposited on debris fans by historical debris flows in Grand Canyon (modified from Melis and others, 1994) and by Holocene debris flows from Prospect Canyon.

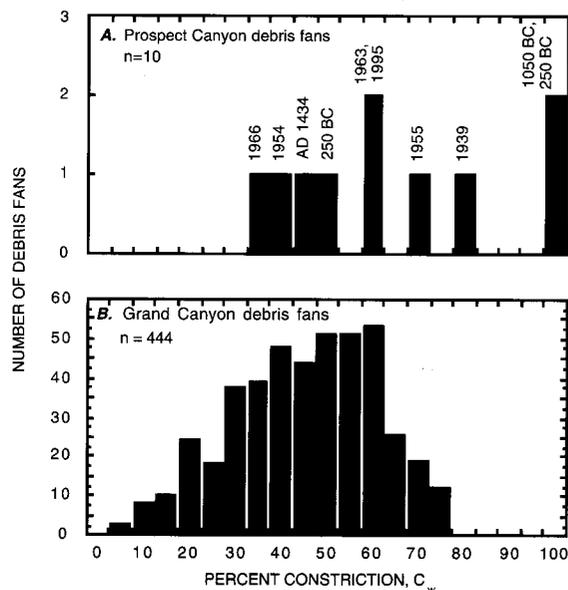
**Figure 35.** Constrictions of debris fans. A, Maximum extent of Prospect Canyon debris fans aggraded by Holocene debris flows and reworked by the Colorado River (table 10). B, Debris fans in Grand Canyon (Melis, 1997).

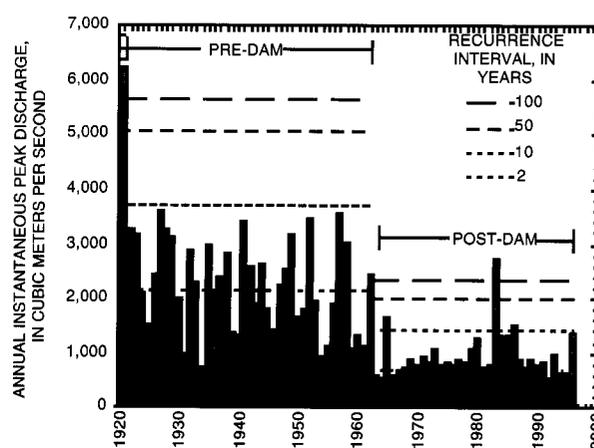
**Figure 36.** Annual series of instantaneous peak discharges for the Colorado River near Grand Canyon, Arizona. Recurrence intervals were calculated using a log-Pearson type III distribution for pre-dam (1921–1963) and post-dam (1963–1995) discharges.

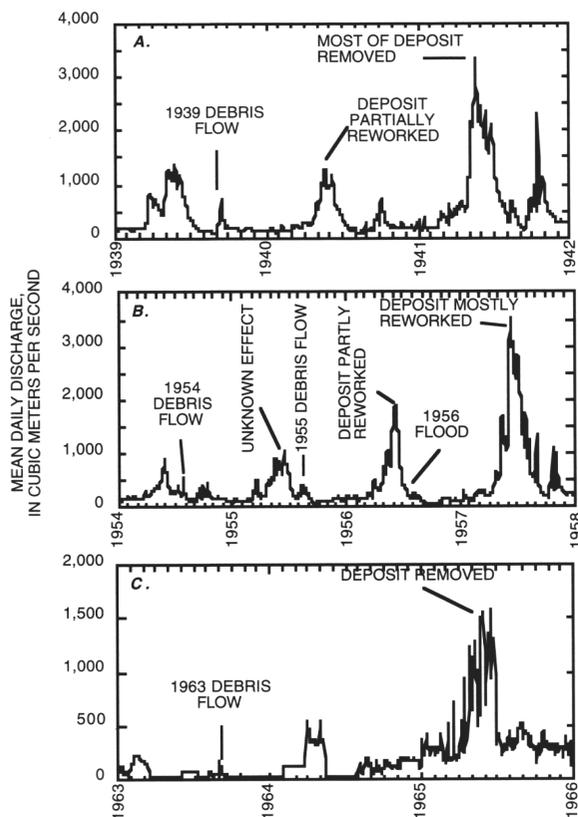
**Figure 37.** Hydrographs of the Colorado River showing the timing of tributary floods and debris flows and reworking by river discharges. A, 1939 to 1942. B, 1954 to 1958. C, 1963 to 1966.

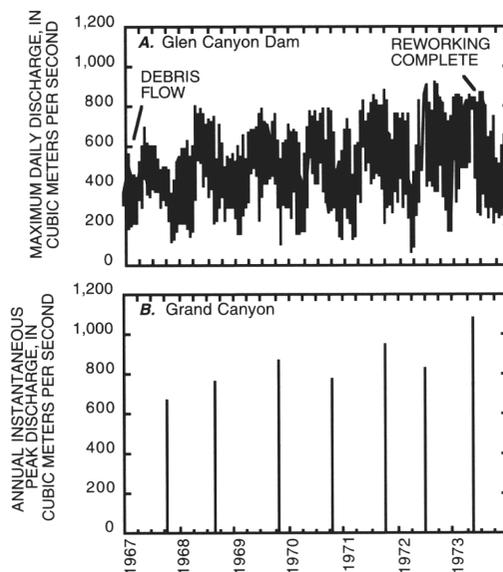
**Figure 38.** Hydrographs of the Colorado River from December 1966 to 1974 showing the timing of the 1966 debris flow and releases from Glen Canyon Dam. A, Maximum daily discharge. B, Annual peak discharge.

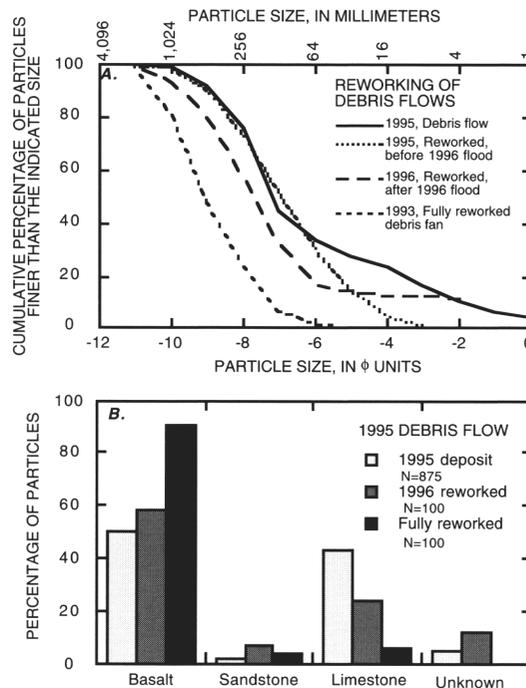
**Figure 39.** Effects of river reworking on sediment particle size and lithology on the Prospect Canyon debris fan. *A*, Comparison of the particle-size distribution on the intact and reworked margins of the debris-flow deposit. *B*, Comparison of rock types transported in the main lobe of the 1995 debris flow with the lithologies of sediments on the reworked debris fan.

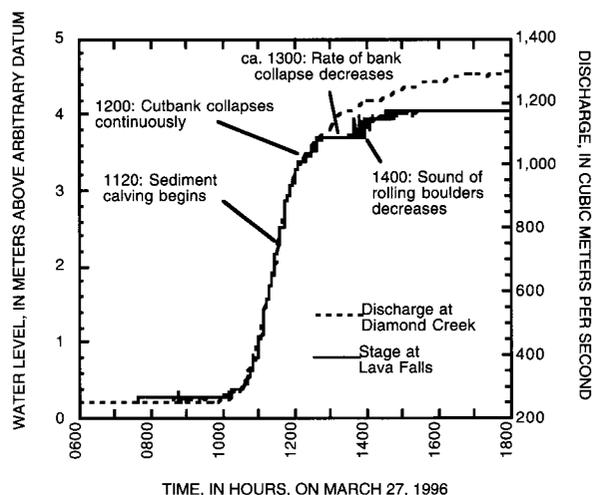
**Figure 40.** The relation between stage, discharge, and reworking of the debris fan at Lava Falls Rapid during the 1996 controlled flood. The stage record at Lava Falls Rapid is for March 27, 1996, and the hydrograph for the Colorado River above Diamond Creek gaging station is adjusted for a discharge-independent travel time of 7.46 hrs.

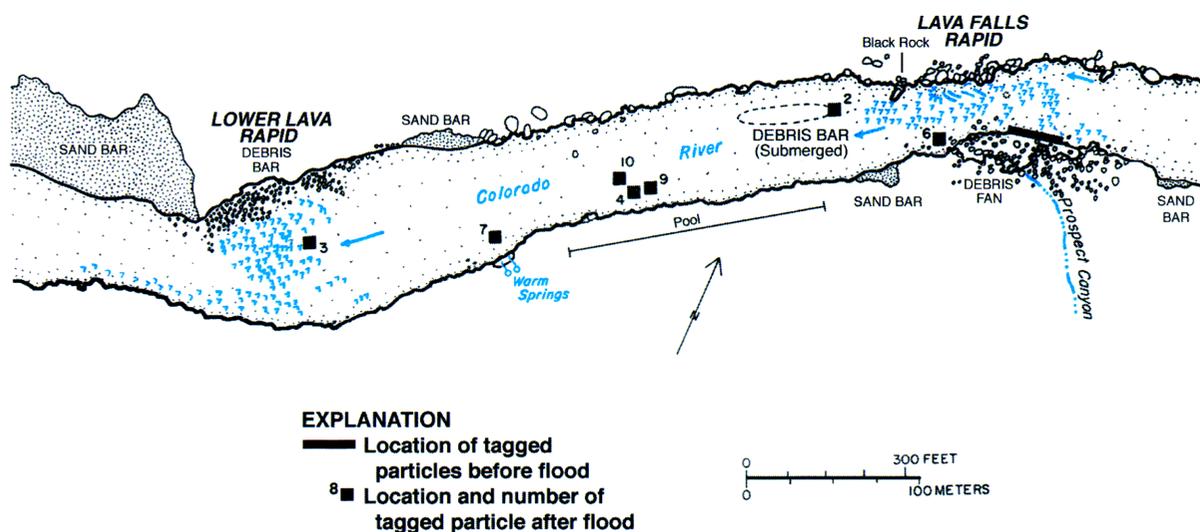
**Figure 41.** Depositional sites of eight radio-tagged cobbles and boulders transported downstream from Lava Falls Rapids during the 1996 controlled flood (see table 11).

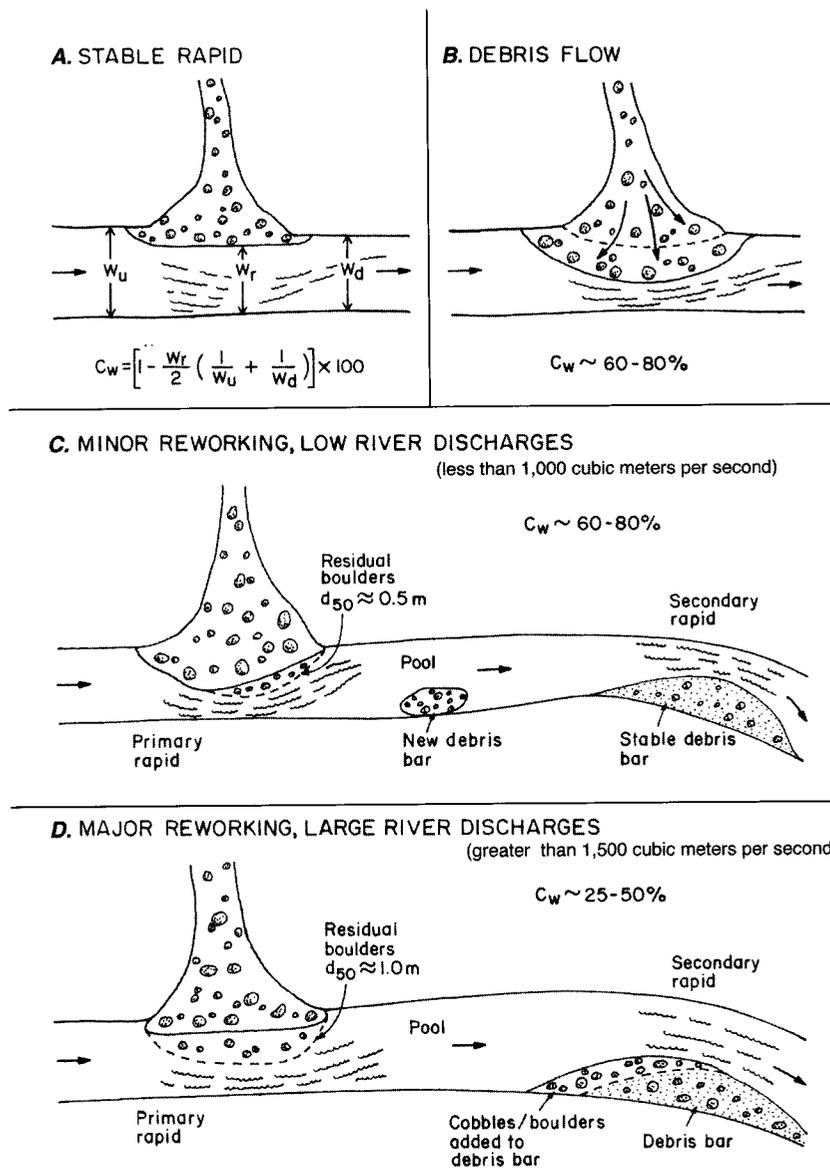
**Figure 42.** Schematic diagram showing a conceptual model of aggradation and reworking of a typical debris fan by the Colorado River in Grand Canyon. A typical fan-rapid system consists of a debris fan, a reach of whitewater, a downstream pool, and alternating bars farther downstream. This model is modified from Kieffer (1990). *A*, At stable, previously reworked rapids, the channel usually is constricted by 50 percent (Kieffer, 1985). In the case of Lava Falls Rapid, the constriction from 1872–1939 was about 3 percent. *B*, Debris flows seldom dam the Colorado River. Instead, deposition generally constricts the river by 60–80 percent. The elevation of the bed rises, partly because boulders reworked from the debris fan are deposited in the main channel or near the opposite bank. *C*, Low discharges (less than 1,500 m<sup>3</sup>/s)—whether small pre-dam floods, typical dam releases, or the 1996 controlled flood—may erode the distal margins of newly aggraded debris fans and widen the constriction. The degree of widening is dependent on local topographic conditions of the fan and mainstem channel, particularly the stage-discharge relation and water-surface fall, as well as the particle-size distribution of the debris-flow deposit. Debris eroded from the debris fan is deposited in the downstream pool. *D*, High discharges (greater than 2,000 m<sup>3</sup>/s)—large pre-dam floods or unusual dam releases such as in June 1983—typically remove most of the new deposit, leaving a residual lag of boulders on the debris fan and in the widened rapid. At low discharges, the widened rapid may be more constricted than before the debris flow owing to the arrangement of immobile boulders and deposition on the downstream edge of the debris fan. Smaller boulders and cobbles are transported through the pool to the secondary rapid and deposited on the downstream debris bar.
