MONITORING AGGRADATIONAL AND DEGRADATIONAL TRENDS ON THE MIDDLE RIO GRANDE, NM

**Robert Padilla, Bureau of Reclamation, Albuquerque Area Office, Albuquerque, NM;
Christi Young, Bureau of Reclamation, Technical Service Center, Denver, CO**

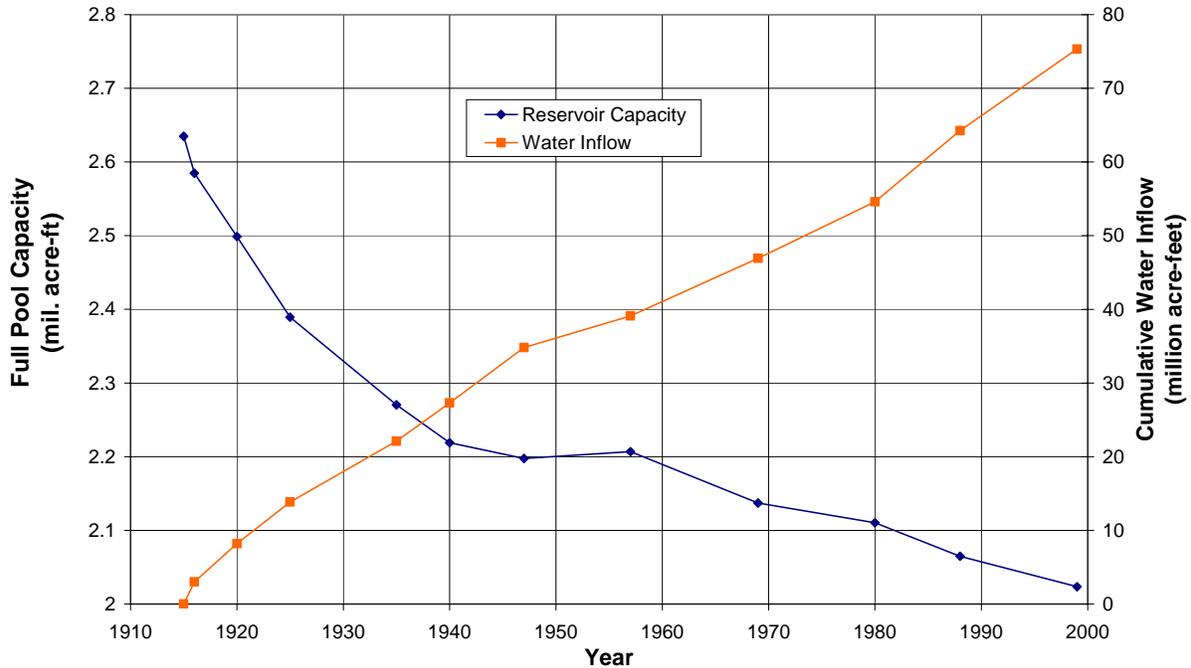
entering the reservoir is trapped. Figure 1 shows how reservoir capacity and cumulative water inflow have varied over time. Over 600,000 acre-feet (23 percent) of storage were lost between 1916 and 1999 with the highest rate of reservoir sedimentation occurring prior to 1940 (Collins and Ferrari, 2000).

Figure 1 Elephant Butte Reservoir Capacity and Cumulative Water Inflow vs. Time

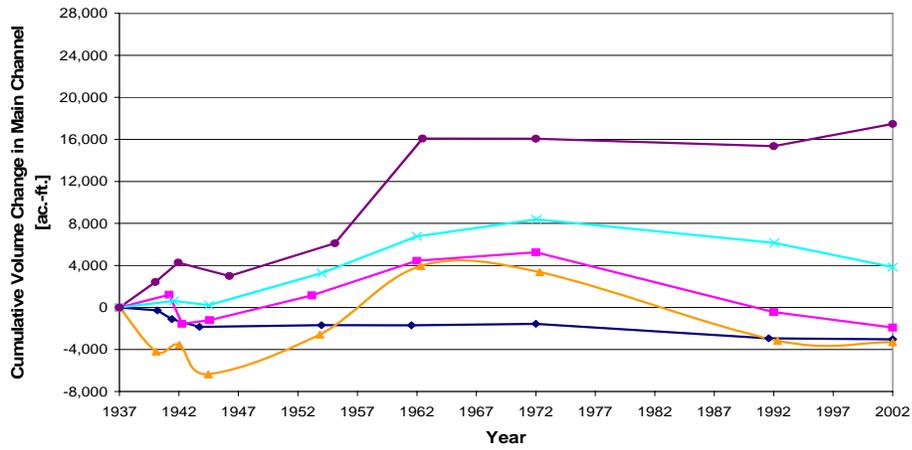
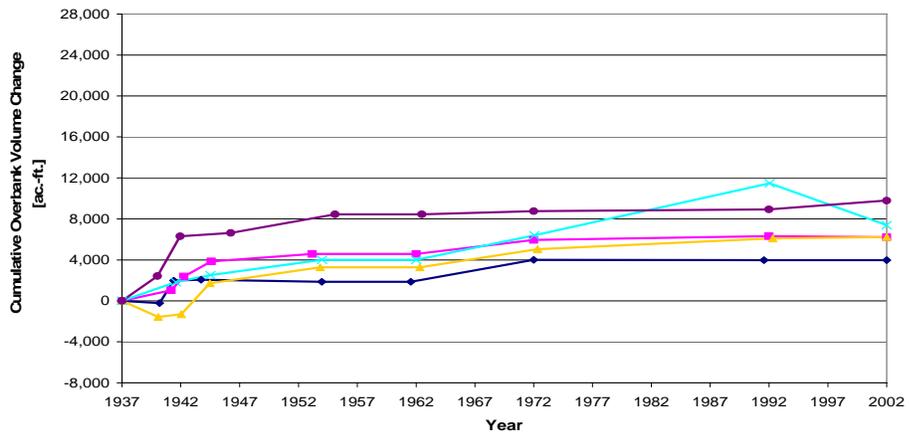
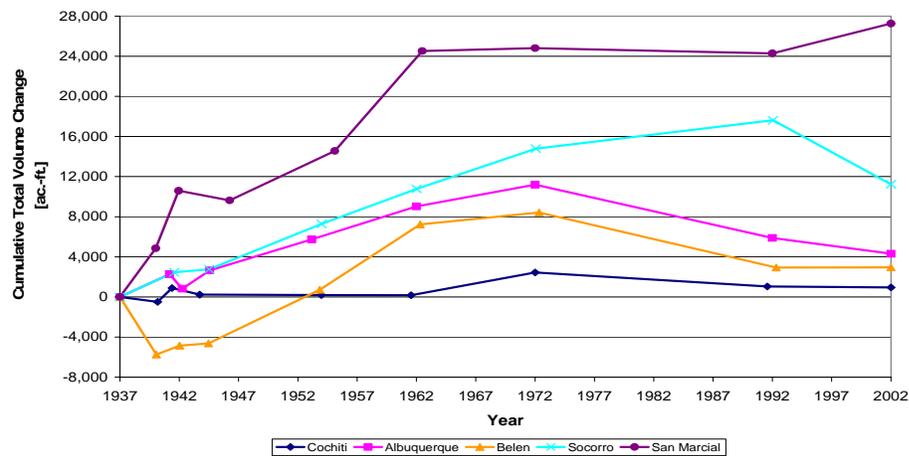
Comparison of the figures shows that the downstream-most San Marcial reach has experienced the most sediment accumulation, whereas the main channel of the upstream-most Cochiti reach has consistently lost sediment. The three middle reaches have varied between aggradation and degradation trends over the study period. The floodplains for all reaches experience most of the recorded accumulation prior to 1972 and have remained relatively steady since then.

Figure 2 Cumulative Sediment Volumetric Change from 1937 – 2002
 (a) Main Channel, (b) Overbank, and (c) Total
